Beaulieu Park Station Progress
Major Projects Portfolio

Issue 114
27th November 2024

Continuous Learning & Improvement Cascade
Eastern Routes Capital Programmes

Shared Learning from an Accident: Signal Post Finger Injury

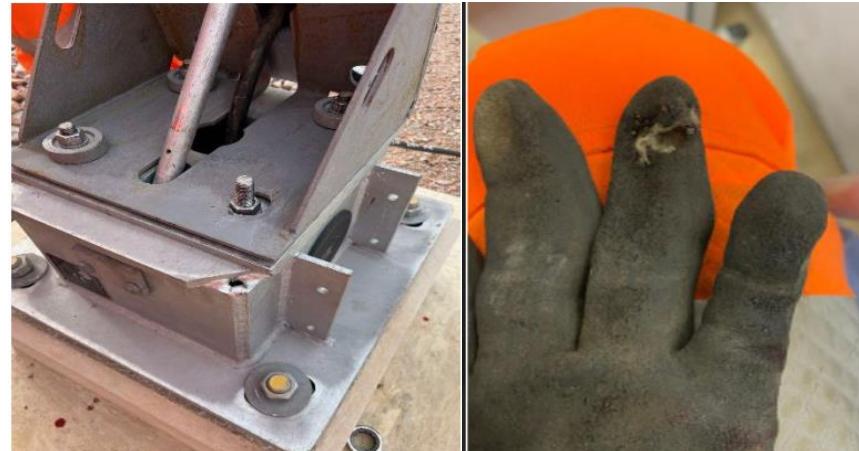
Once on site, the Construction Manager (CM) noticed the wedge's incorrect installation and that the hinge was coming from the transfer box. Four nuts and washers had been loosened, meaning nothing was holding the base of the hinge in place.

Photos of signal post wedge & damaged glove

To rectify the situation, the CM devised a plan of action, re-briefed the team, and confirmed that they all understood what was required of them before recommencing work. The CM, wearing the appropriate gloves, removed a washer and nut from one thread. Team members were asked to take the weight of the signal post as per the Collis Operation Manual. This dropped the bottom plate flush to the transfer box. As the CM proceeded to wind the nut down with his hands, a team member accidentally lowered the signal post slightly which resulted in the base kicking up and trapping the CM's finger between the nut and the wedge, causing a small cut. The CM was taken to hospital to have the wound checked. They returned to work on the following shift on full duties.

- The wedge was installed incorrectly. The Collis Manual provides detailed illustrations of the installation process of the signal post. However, the wedge installation only provides a technical drawing that demonstrates what looks wrong.
- If the CM had fastened the bolts onto the thread using a spanner instead of his hands, his finger might not have been pinched, and the spanner could have taken the impact.
- Other team members did not challenge the CM using their hands instead of the correct tools.
- The Construction Manager should only be overseeing site works, not be carrying out physical works.

- All other signal structures were checked and corrected across the project within the available possession.
- The task brief sheet was updated with more details about the wedge removal.
- Sub-contractor provided a shared learning at a weekly safety stand down.
- Similar works are to be carried out during the Christmas period; therefore, a full Safety review of Christmas works was undertaken to ensure all learnings are implemented.
- A Planned vs Actual assurance review will occur during these works to assess and monitor the associated risks.

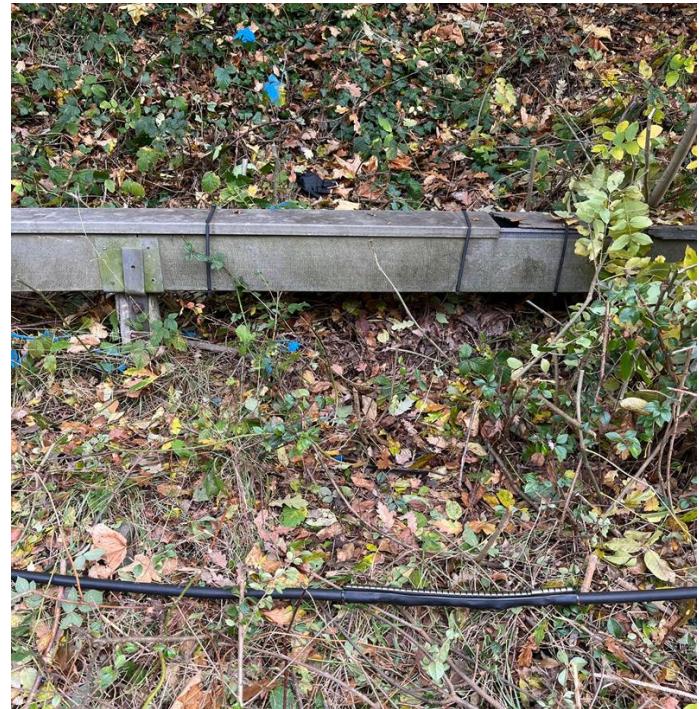
On the 23rd October, a track circuit fault was reported to Fault Control on the Midland Mainline Electrification (MMLE) Programme, near Humberstone Road Junction. A contractor was working in the area clearing vegetation before undertaking geotechnical investigations. The contractor assessed the area using a bespoke checklist and a ground surface cable was identified (not contained within a trough).

On completion of the de-vegetation, which involved a petrol hedge trimmer (see photo) the team moved on to the next location. The team were later notified of the track circuit fault, and the cable was found to be damaged.

It took some time for the fault team to locate the damaged cable due to miscommunication between the Person in Charge of Possession (PICOP) and the contractor, who believed the fault was not associated with their works.

Photo above showing repaired cable and locations of proposed geotechnical investigations (blue

- Pre-start walkouts to be undertaken to identify hazards and potential risks
- Any cables outside troughing should be reported to Network Rail
- Photographs and videos to be taken before and after the works
- If cables are close to the work area, shielding should be considered and included within the Point of Work Risk Assessment
- Signaller to be contacted prior to commencing work to make them aware that the team are undertaking vegetation works and what locations. Follow up call to the Signaller after works are complete
- Internal procedure updated to include above actions

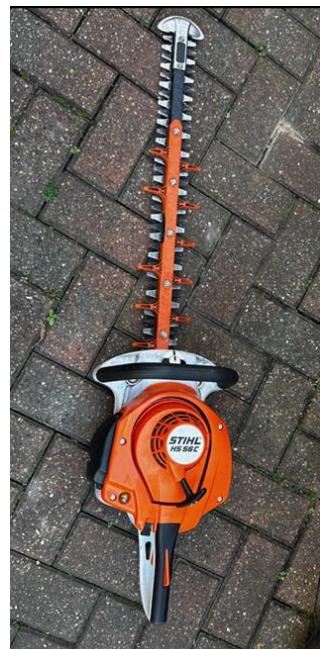
Petrol hedge trimmer
