CLIC

Bradford Forster Square, Major Projects Portfolio

Issue 131
09th April 2025

Continuous Learning & Improvement Cascade
Capital Delivery Eastern Region

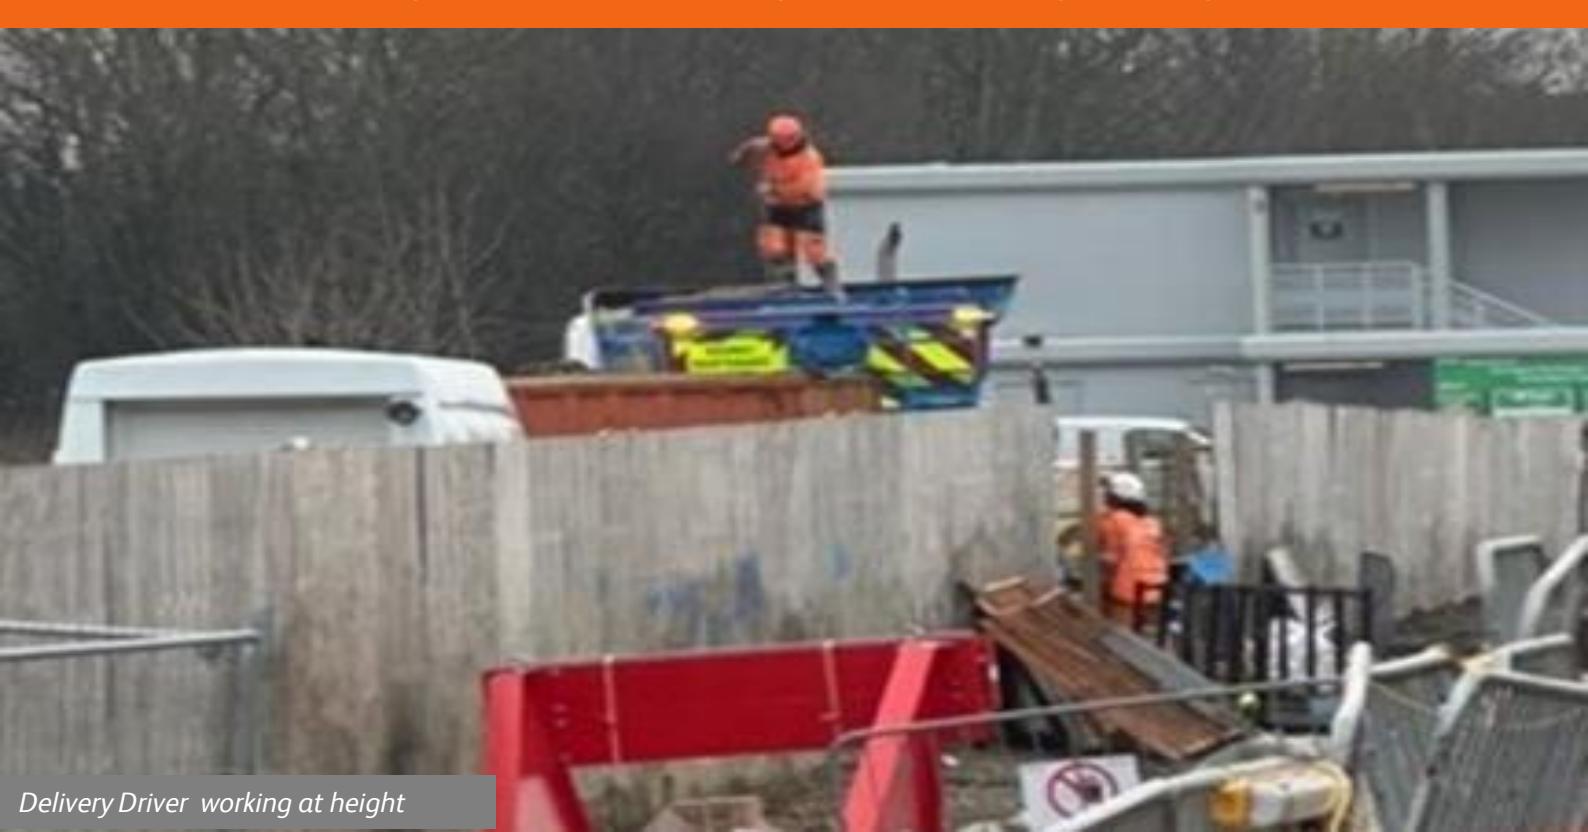
During piling operations at Darlington, a concrete delivery driver climbed onto the rear of the concrete mixer to dislodge aggregate that had become blocked in the vibrating bins. He did not alert the supervisor, and no controls were in place for working at height. A supervisor spotted the driver and immediately stopped the work.

- The driver did not receive a site induction on safety rules on arrival.
- The driver did not receive a task briefing.
- The supervisor was not alerted about the blockage.
- The driver did not follow the company safe system of work for unblocking the aggregate bin, which would not have required him to work at height.
- The task was not risk-assessed.

- How do you ensure that ALL suppliers are inducted on the site safety rules and task risks?
- Do you know what to do if the work changes?
- How do you manage and assess risks for late changes?
- Do you know what to do if you see something that may be unsafe?

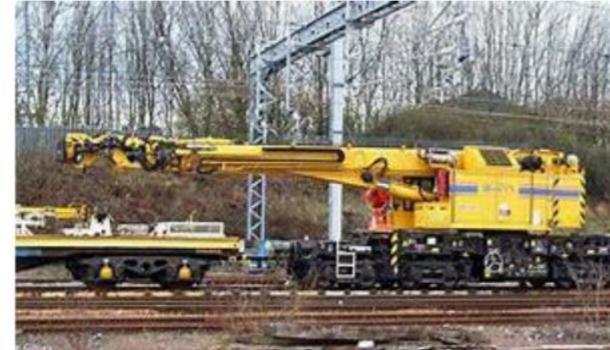
Kirow Crane Incident

On Saturday 15th March 2025 at 20:37 a serious incident took place on a Rail Systems Alliance, Scotland track renewal site. The incident involved colleagues working with and around two Kirow cranes.

During the works, a colleague was injured when two Kirow cranes came into contact whilst undertaking lifting operations for the new track.

The injured colleague was taken to hospital and is being treated for injuries to his arm.

Never enter an agreed exclusion zone, unless directed to by the person in charge.

Always direct / control plant movements from a position of safety

Always maintain good communications during plant movements.

Always make sure lifting and plant movements are briefed and understood.

Always make sure communications protocols including complex sites with multiple comms channels are clear, briefed and understood.
