CLIC

Stanningley Tunnel Project
Renewals & Minor Enhancements

Issue 141
18 June 2025

Continuous Learning & Improvement Cascade
Eastern Routes Capital Programmes

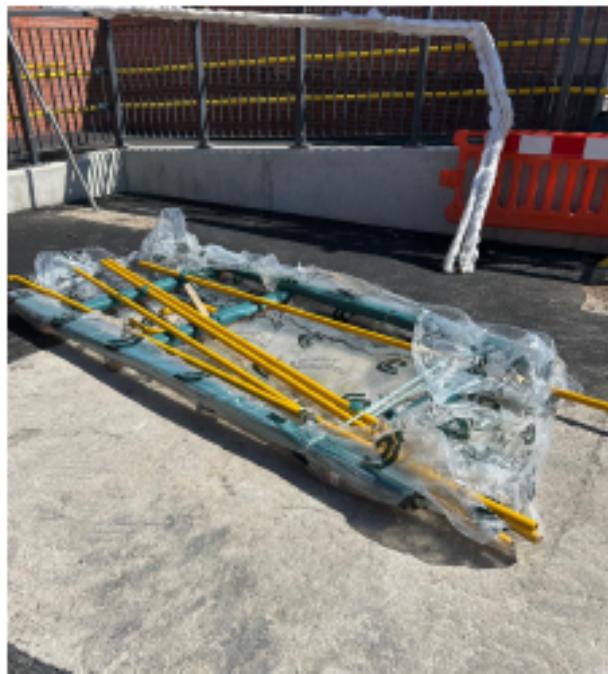
An AmcoGiffen Site Operative was removing a section of handrailing from a timber frame, prior to installation onto an access ramp. As they were carrying a section of handrail from the pallet, a gust of wind blew the shrink wrap (still attached to the pallet) around their foot; causing the IP to trip and fall to the ground injuring their right elbow.

The IP received first aid on site and visited A&E later that evening. Following an x-ray, the IP was found to have a potential fracture of their radius and referred to a specialist fracture clinic.

- Evaluate the workplace for potential slipping and tripping hazards (including packaging materials).
- Can packaging be reduced, substituted or eliminated at source?

- Establish clear guidelines for safely removing packaging materials, including the use of appropriate tools and techniques. Where materials are partially unpacked ensure that any loose wrapping is secured.
- Where possible, fully remove all packaging so as not to introduce any additional hazard to the workplace.

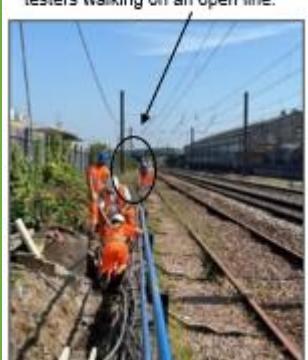
Two testers were observed walking on the operational Down Goods Loop (line speed 25 mph). They had been working in the Goods Loop REB conducting prep testing and needed to check a dis box. En route, they walked on the cess side of the vortox fencing and requested permission to pass the sub-contractor team installing troughing. The troughing works had created multiple holes, troughing and string lines which were obstructing the safe access route. After completing checks at the dis box, the testers discussed the safest return route. With alternative paths blocked by overgrown vegetation and the main route obstructed, they chose to walk on the Down Goods Loop. Although aware it was operational, they believed it was safe due to the line being clipped and scotched.

- The testers were working under a separated safe system of work, and they deviated from this without authority.
- There was reluctance for the incident to be reported due to the individual's fearing repercussions for their actions and by the team who witnessed it due to it being seen as revenge for a previous incident which was reported by the testers.

Photo taken showing the signalling testers walking on an open line.

- A point of work risk assessment developed and rolled out across all project teams.
- Alstom engaged with their Labour Supplier organisations the need for non-technical skills for their teams
- Checklist introduced to prompt discussion / assist in integrating activities of different disciplines at weekly reviews.
- A project stand down held on processes and importance of adhering to the SSOWs in place.
- Increased assurance checks and site visits introduced to check work is being delivered in line with procedures.

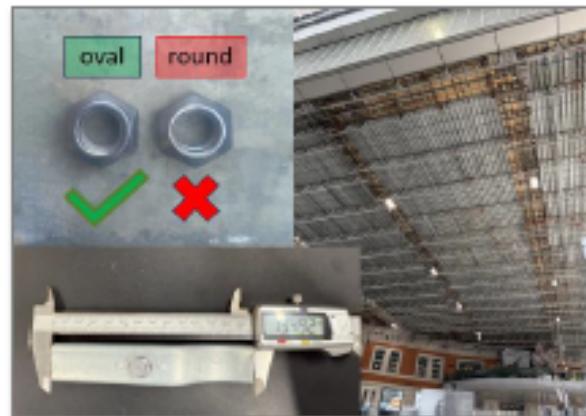
On Monday, 9 June, a passenger reported an object falling onto the concourse floor. The object was confirmed to be a locking clip from an aluminium plank used in the HAKI suspended scaffold system.

The affected component is assembled by HAKI using a locking nut intended to remain secure under normal conditions. The locking nut, supplied by another manufacturer, should have been crimped or pressed. However, in this instance it hadn't been.

It is believed that vibration and/or thermal expansion and contraction caused the assembly to loosen, resulting in the clip and its connecting bolt falling. The locking nut remained in place on the underside of the deck.

A properly compressed nut should feature an oval-shaped hole. The failed component (pictured) was found to have a round hole. HAKI has raised a non-conformance report regarding this issue.

- Precautionary Checks:** HAKI advises that users inspect the tightness of the nut and bolt securing the locking device. This can be done using two wrenches to confirm the locking nut is fully functional. Any decking panel with a loose or damaged locking device must be removed from service, in line with the product manual.

- Inspection Prior to Installation:** All scaffolding components — regardless of manufacturer — must be inspected thoroughly before installation, especially in applications above areas accessible to the public.

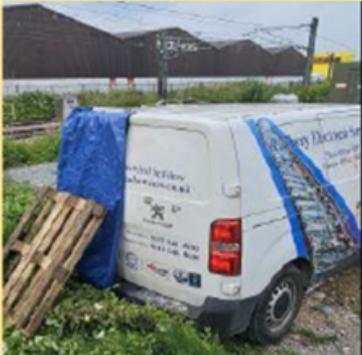
RES operatives were travelling between Cambridge South and Coldham's Road when they noticed a burning smell coming from the back of their work van. Upon arrival at Coldham's road they opened the rear doors of the van and that a fire had started. The operatives attempted to extinguish the fire using an extinguisher they carry in their van. The operatives called emergency services who arrived at 1525 and fully extinguished the fire. Damage caused to the back door of the van, internal and external.

The van after fire extinguished

The cause of the fire is currently under investigation. However, in the work van there were numerous electrical items, such as batteries as well as blow torches which will be part of the investigation remit. The operatives had completed works prior to travelling to another site so the equipment used by the operatives is being assessed to identify if this could have led to the fire.

Teams have been advised to check their work vans for emergency response equipment along with equipment / materials.

A review of equipment and materials stored in work vans is to be conducted and risk assessments are to be reviewed to ensure it covers the risk of a fire starting and additional hazards that may be present.

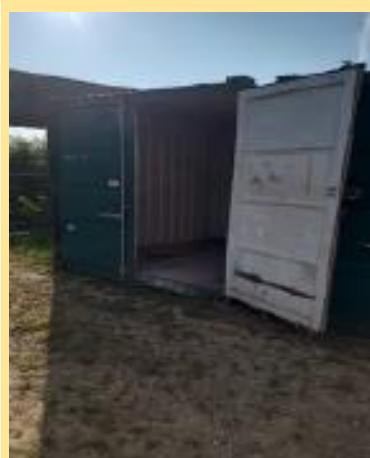
Compound Unit

Upon arrival at the site compound following the weekend, the team discovered that the padlock had been cut, allowing unauthorised access. Empty storage containers had been found to be open, indicating that individuals had entered the compound without permission.

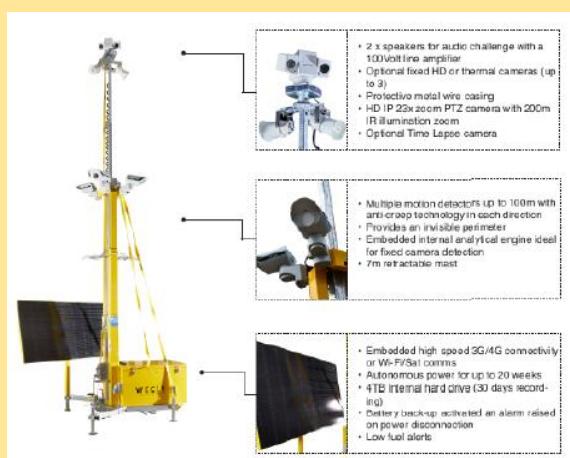
WCCTV Installation being deployed at the Site

- Security review: Assessment of planned security measures and storage strategy, adhering to a just-in-time approach due to the site's remote location.
- WCCTV installation: Completion of the WCCTV Rapid Deployment Tower installation, monitored 24/7 by an external security company. A designated responsible person has been identified to manage the system and power source.
