# CLIC

Barnetby Maintenance Delivery Unit Project  
Renewals & Minor Enhancements

Issue 142  
25 June 2025

Continuous Learning & Improvement Cascade  
Eastern Routes Capital Programmes

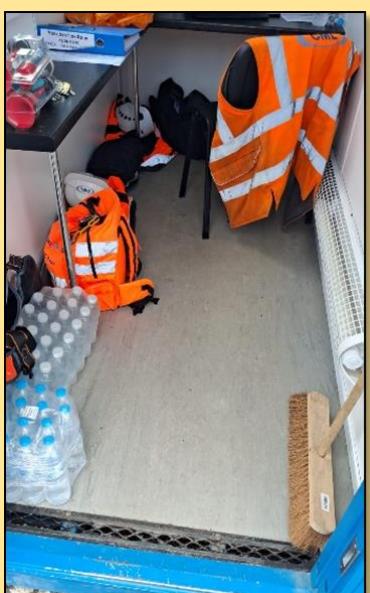
Welfare Unit

When entering the site office, the IP caught their foot on the bag strap of an emergency kit bag that had been left on the floor along with several other items in the site office. As a result of this the IP fell forward striking their head on the shelf in the office. This resulted in a slightly swollen eye, with a small graze to their eyelid, caused by the prescription safety glasses they were wearing being forced against their face from the impact.

It was noted that PPE such as helmets were left on the floor of the office, these should be stowed away safely so they are not damaged.

The site manager conducted a TBT on housekeeping the site was checked for obstructions to walkways with any items stowed away correctly covering the following:

- **Always** Keep walkways clear of obstructions and maintain housekeeping not only on site but in the welfare and office areas.
- Safety equipment is provided to keep you and your workmates safe- **Don't leave it laid about on the floor where it could get damaged.**

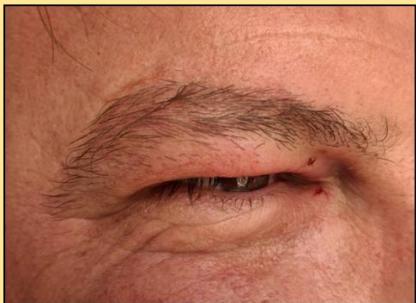
Injury to eye

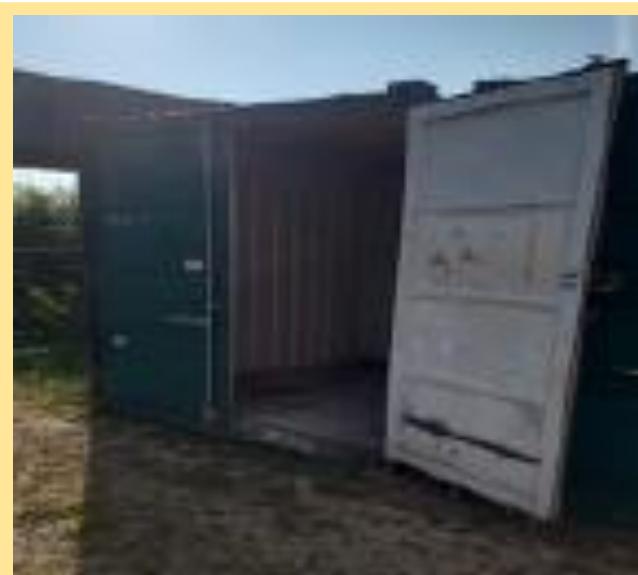
Upon arrival at the site compound following the weekend, the team discovered that the padlock had been cut, allowing unauthorised access. Empty storage containers had been found to be open, indicating that individuals had entered the compound without permission.

Compound Unit

The site is in a remote location.

The site is still in set up and therefore no materials or equipment where present.

Incident reported to the British Transport Police (BTP).

- Security review: Assessment of planned security measures and storage strategy, adhering to a just-in-time approach due to the site's remote location.
- WCCTV installation: Completion of the WCCTV Rapid Deployment Tower installation, monitored 24/7 by an external security company. A designated responsible person has been identified to manage the system and power source.

BTP has now added the location to their local patrol route.

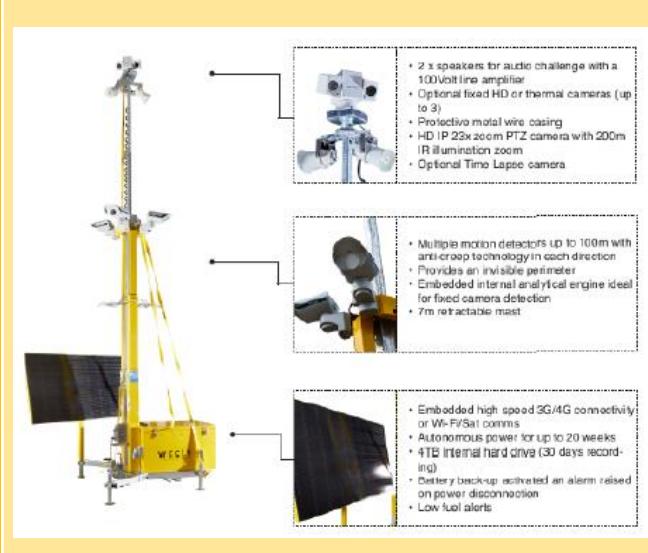
WCCTV Installation being deployed at the Site

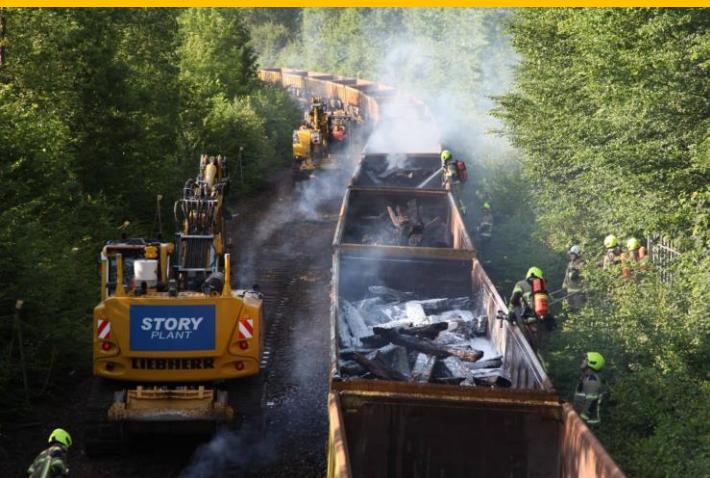
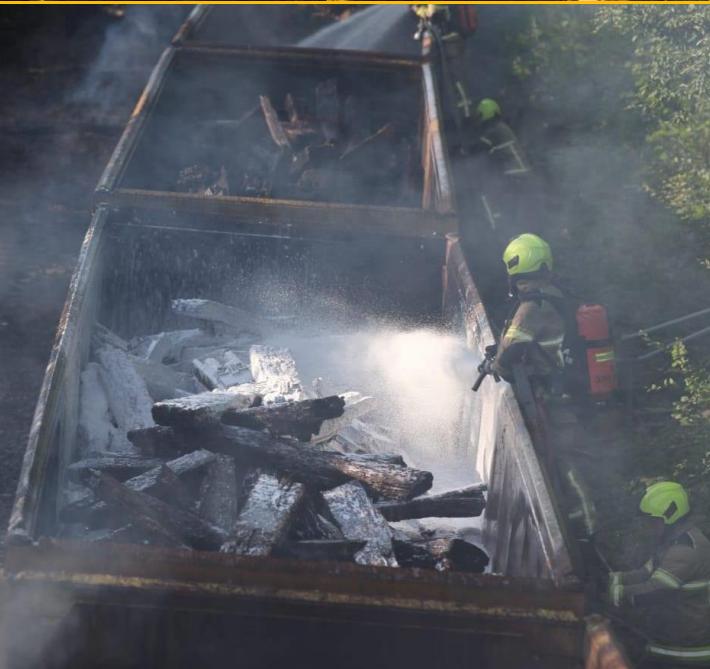
Sleepers that had been loaded onto the engineering train were smouldering due to the heat from hot works associated with rail cutting. Fire brigade was informed.

Incident occurred due to the heat from hot works associated with rail cutting.

The fire crew arrived at site and damped down the wagons.

The remaining sleepers were loaded, and the wagons were damped down via the bridge

Level 1 investigation underway.

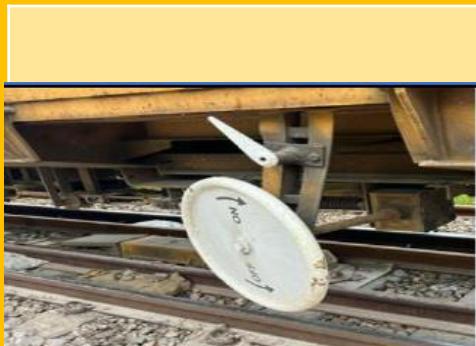
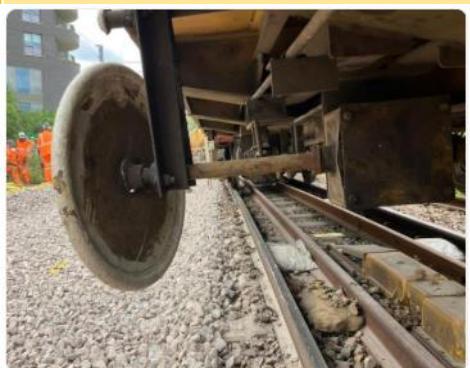
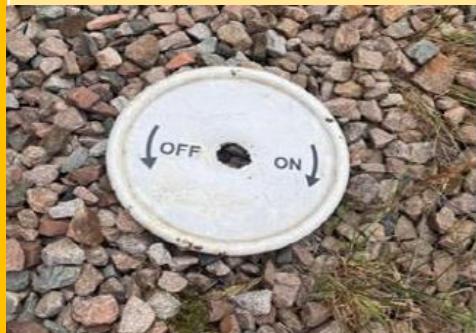
A Road Rail Vehicle (dozer) blade has come into contact with an engineering train break handle whilst trimming the base stone. The engineering train was stationary at the point of contact. Prior to the engineering train departing, the Plant Operating Manager and SCO were informed and the necessary checks were completed to ensure safe travel.

- A Stand-down of site for the investigation has taken place
- The Plant Operating Manager inspected the wagon and confirmed it is safe for train to depart.
- The train wagon was sent to the maintainer to assess the damage.

Level 1 investigation is on-going.

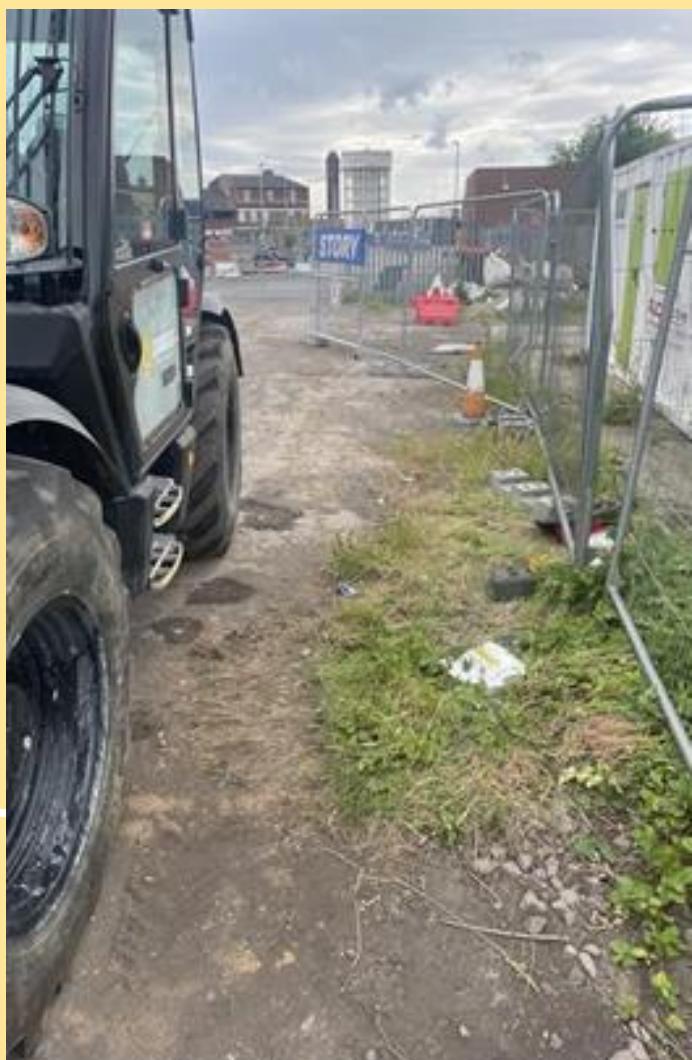
Whilst reinstating the dwarf wall on the North subway the dumper driver tried to pass the stationary telehandler through a tight gap and came into contact with the telehandler causing damage to the glass panel on the telehandler door. Glass remained intact within the door

*Location of incident*

Driver from Onsite admitted rushing and accepted responsibility.

The driver misjudged the available space between the stationary telehandler and dumper he was driving.

The site has a small operational footprint.

Onsite team arranged for replacement glass to be fitted in the telehandler door.

Incident investigation to be undertaken with Onsite Contractor.

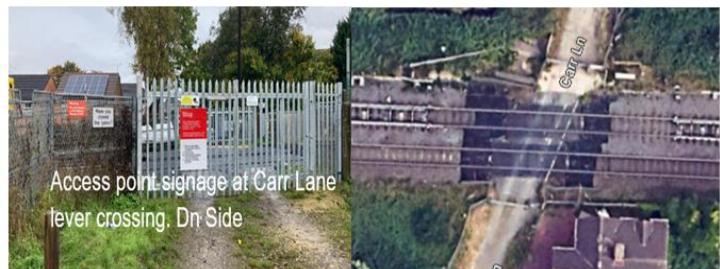
A Near Miss occurred between a member of staff vehicle and an Engineering train while attempting to cross Carr Lane Level Crossing. This incident happened within the possession limits of a planned track renewal and involved an Isolation team working on behalf of CRSA. The isolation plan was done in two phases and in line with the planned worksite. In phase 2 the Authorised Person (AP) attempted to cross Carr Lane Level Crossing to collect some belongings for his Earthing Assistant (EA) without contacting the signaller. The EA opened the Level Crossing gate whilst the AP drove over the crossing. On attempting to cross over, a Freightliner train traveling on the Down Lincoln Flyover line had to apply the emergency break and horn whilst the AP reversed back to clear the line.

- The Carr Lane level crossing procedure was not followed.
- The Authorised Person did not attempt to contact the signaller before crossing therefore not given permission by the signaller to pass over the level crossing.
- The AP did not utilise the allocated time at the start of the shift to familiarise the team with the area (the planned start time was 22:00 however the team started on site at 00:00)
- The AP along with other members of the OLE team did not sign into the CRSA site access and therefore did not receive the site access briefing.
- The Nominated Persons briefing of a complex isolation to the Authorised Persons took place in the car park rather than the cabins provided.
- The Authorised Person was confused on the location of the earthing location and had to contact the Nominated Person for clarification of earthing location.

Photos: Carr Lane Level Crossing. Double gate access at each side of the crossing with clear crossing instructions on the front of the gate.

- Improvements to infrastructure signage and warnings at Level Crossings within work areas implemented by site team
- Nominated Persons competence and training requirements reviewed as to conducting suitable site briefings that includes any access arrangements.
- All workforce rebriefed that they must receive a Site Access Brief before accessing the track. Nominated person or Person in Charge (PIC) to check all staff have received the site brief before deployment
- Increased assurance checks and site visits introduced to check work is being delivered in line with procedures.

- Review of access risks and arrangements in Task Briefs to be included in the Safe System of Work Pack if required.
- Whiteboard briefings are to include a reminder of crossing and access arrangements at all level crossings within the work area
- Level 3 On Call and Duty Management to be briefed on the management process and the wellbeing of staff post any accident or incident.

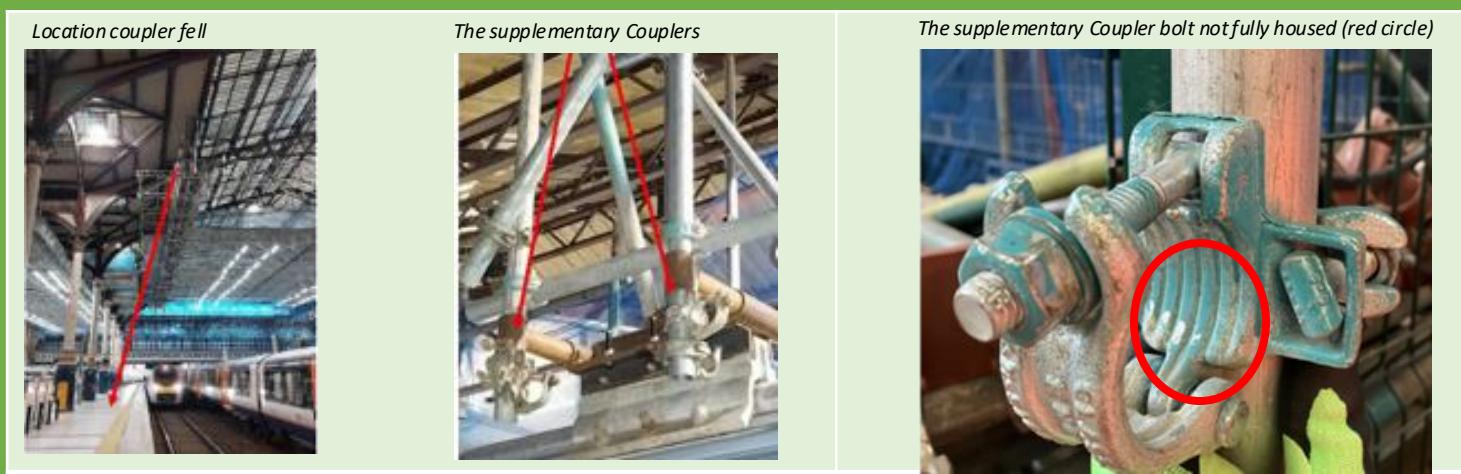
During installation of a tube and fitting hanger for the suspended scaffold, a supplementary coupler became loose and fell approximately 15m onto the station platform. The platform had an exclusion zone in place at the time of the incident and the coupler landed within it. There were no injuries or damage. The investigation concluded that the coupler had not been correctly tightened and vibrated loose when the scaffolder was working on an adjacent fitting.

- The coupler was not fully housed in the fitting. Due to the number and types of coupler the scaffolder was working from touch / feel. Not being fully housed in the fitting the coupler became loose under vibration from the continuation of works on the scaffold installation.
- Encapsulation (netting) had not been installed as per the agreed methodology allowing the coupler to drop onto platform and not be contained at a high level .
- Communication to the night shift Supervisor did not adequately cover the controls required i.e. the encapsulation.
- The chain of documentation did not suitably pass risk controls from the Work Package Plan into the Task Briefing Sheet and therefore those undertaking the works were not adequately aware of the risk controls.

- All couplers already installed have been physically checked where there is a risk of them falling from height.
- Future couplers will use swivel type to allow visible fitment of bolt to housing.
- Encapsulation requirements now fully detailed in the Task Briefings and installed during hanger installation.
- Review of all WPPs and TBS to ensure controls are adequately captured.
- More emphasis of on-site review of TBSs during site engagements to ensure processes are being followed.
- A back shift implemented once per week to establish better two-way communication with the night shift team.

- Specific risk controls detailed in the WPP should be incorporated into the Task Briefing Sheet.
- Task briefing sheets including specific controls should be fully briefed and understood by those undertaking the task.
- Point of Work Risk Assessments that require any deviation to the methodology should be assessed to take into account any specific environmental conditions and be approved before deviation.
- Project teams should review what methods they use to assure themselves that teams carrying out tasks are working in compliance with the methodology.

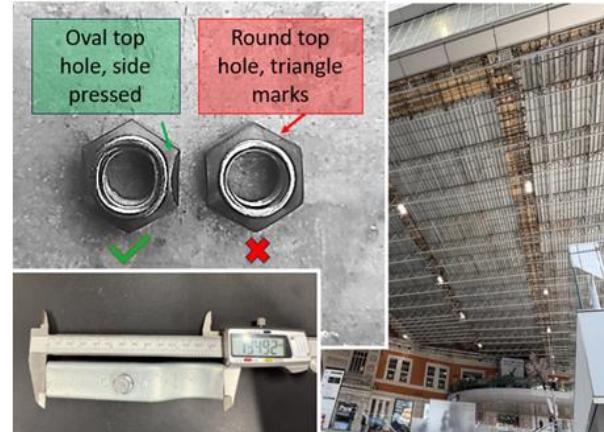
On Monday, 9 June, a passenger reported an object falling onto the concourse floor. The object was confirmed to be a locking clip from an aluminium plank used in the HAKI suspended scaffold system.

**The clip measures approximately 13.5cm and had the potential to cause serious injury or a fatality. Fortunately, no harm occurred in this instance.**

The affected component is assembled by HAKI using a locking nut intended to remain secure under normal conditions. The locking nut, supplied by another manufacturer, should have been crimped or pressed. However, in this instance it hadn't been.

It is believed that vibration and/or thermal expansion and contraction caused the assembly to loosen, resulting in the clip and its connecting bolt falling. The locking nut remained in place on the underside of the deck.

A properly compressed nut should feature an oval-shaped hole. The failed component (pictured) was found to have a round hole. HAKI has raised a non-conformance report regarding this issue.

**Ongoing Investigation:** HAKI is conducting a full investigation into this reported failure of a decking locking device. Based on current information, the root cause has not yet been established. This is the first reported incident of its kind since the product's introduction in 2017 and is currently believed to be an isolated case.

**Structural Integrity:** It is important to note that the incident did not affect the load-bearing capacity of the plank.

All work was halted immediately. The scaffolding contractor is now conducting a full inspection of the nut-and-bolt assemblies on every plank before works resume.

- Precautionary Checks:** HAKI advises that users inspect the tightness of the nut and bolt securing the locking device. This can be done using two wrenches to confirm the locking nut is fully functional. Any decking panel with a loose or damaged locking device must be removed from service, in line with the product manual.
- Inspection Prior to Installation:** All scaffolding components — regardless of manufacturer — must be inspected thoroughly before installation, especially in applications above areas accessible to the public.
- Product Acceptance:** Check whether the scaffolding systems you intend to use on the operational railway have a Network Rail product acceptance certificate.
- Ensure your temporary works design has been thoroughly assessed for potential hazards and risks.
