Issue 143
02 July 2025

Continuous Learning & Improvement Cascade
Eastern Routes Capital Programmes

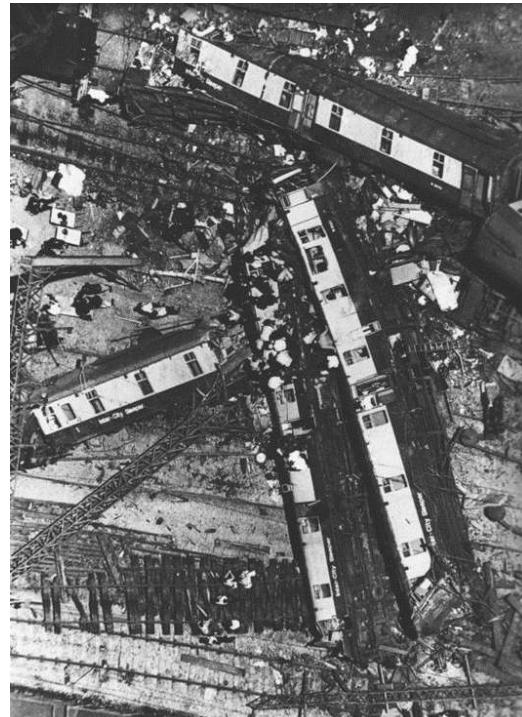
In the early hours of 6th June 1975, a train derailed at Nuneaton resulting in the deaths of 6 people and multiple injuries.

A mile from Nuneaton station, the train passed a lineside board giving advance notice of a 20mph temporary speed restriction (TSR) in place through the station, however, the lights illuminating this board were not working. At the time, it was not practice to provide an AWS (Automatic Warning System) magnet with an advance warning board for a TSR.

The driver and second-man wrongly assumed that the 20mph TSR was no longer in place. Just before entering the station the driver saw an oil lit board marking the actual commencement of the TSR and made an immediate emergency brake application, however, this was too late, and the train derailed on a curve at 100mph:

- The curve was part of a temporary alignment in place during the remodelling of the station layout.
- The locomotive and all but the rear carriage derailed.

- Always stop and report any unsafe situations and intervene to stop safe practices.
- How can we minimise the risk of human error?
- How can we mitigate against the risk of equipment or technology failures, theft or vandalism?
- Beware that in attempting to control one risk, we may introduce new risks.
- Will minimising the amount of temporary or phased works reduce risk overall?
- Minimising the reliance on TSR's will reduce the risk of over-speeding and the risks to those who must establish and remove any temporary restrictions.
- Keep corporate memory alive – Do not forget the tragedies and lessons learnt from the past!

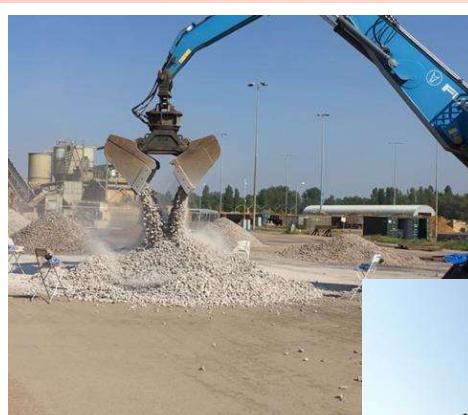
- After 2 days, total particulate matter was reduced by **82%**, and respirable dust by **52%**
- After 7 days, it was not possible to handle the dry untreated ballast (top image) due to dust levels but the Dustite treated ballast remained suppressed (bottom image).

7 day treatment of ballast (left)

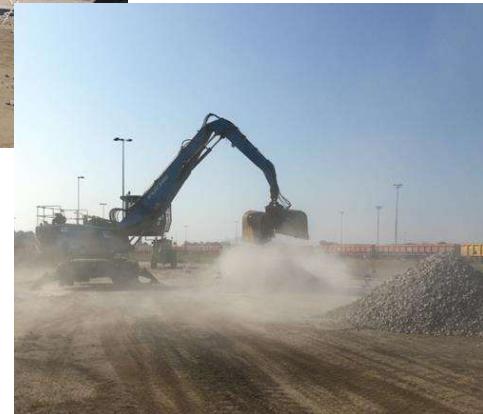
7 day of untreated ballast (right)

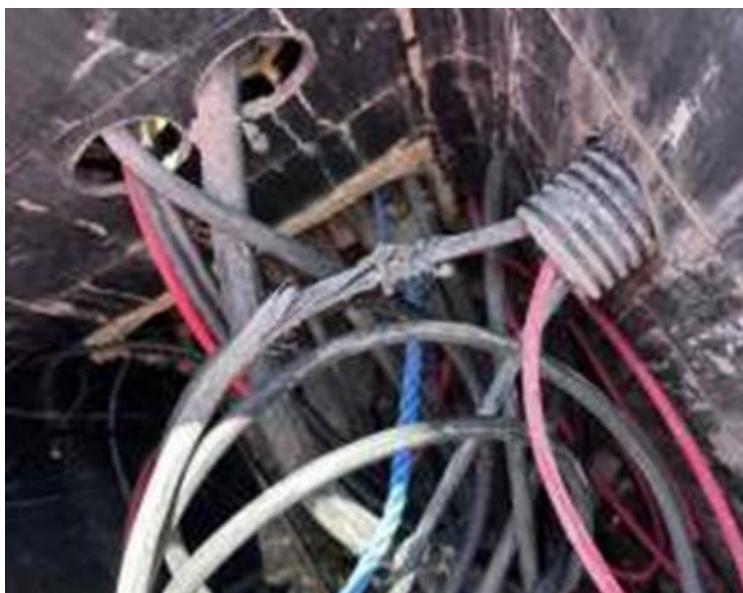
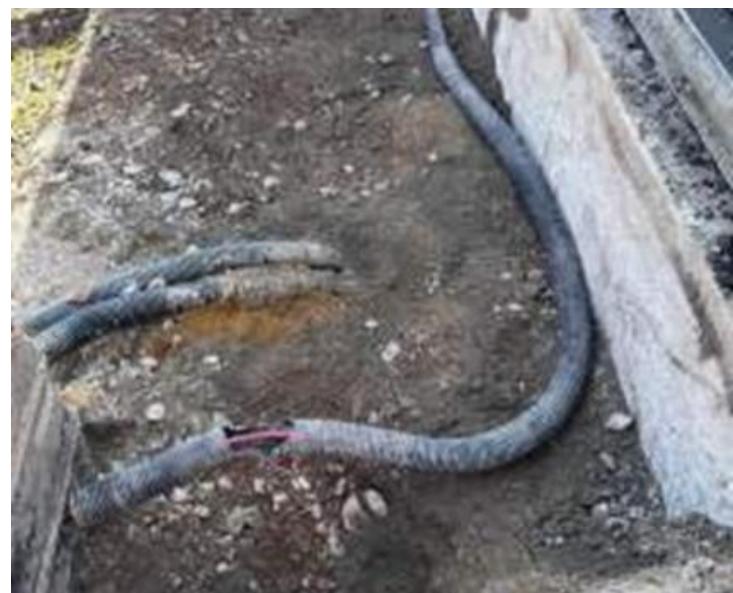
During ACO drain removal on platform 1, the hearing aid loop cable duct was pulled upward as it was encased within the concrete below.

This pulling on the cable meant that it snagged on the chamber opening which has resulted in damage to one cable. Cable duct is being repaired to allow for future repair of cable.

Ducting was fully exposed by hand to confirm route of cable and end connections.

Operatives re-briefed.

- L1 investigation to be completed.
- Cable to be repaired.

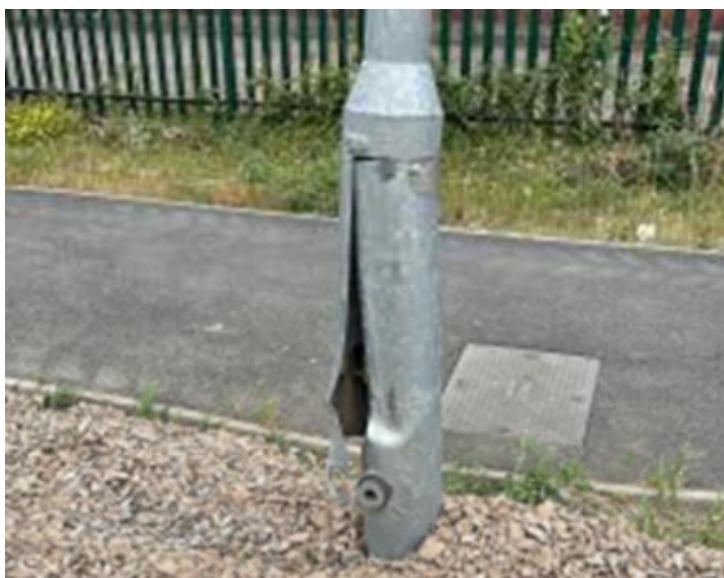
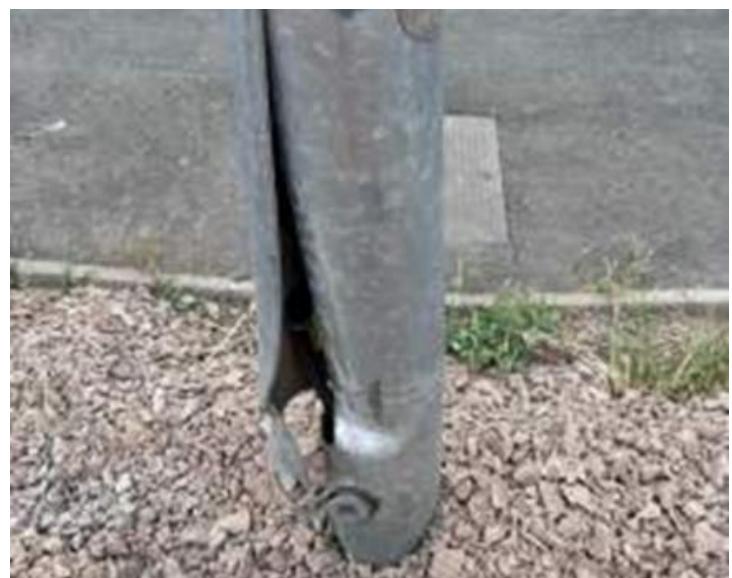
A lighting column located within a non-operational area of the station was discovered to have been damaged. The area adjacent to the lighting column was being used to store aggregate material for the platform works, with excavator and dumper movements. It appears that the column was damaged during work once the stock-pile had reached a low level and the bulk timbers had been removed to allow the remaining aggregate to be removed. The cable within the column was not damaged.

Plant operators were stood down and re-briefed.

Electricians were contacted to isolate and disconnect the column to allow the column to be lowered and protected.

Barriers were installed around each column to protect against further plant movements.

- Repair column and replace damaged parts.
- Level 1 investigation.
