# CLIC

Sharnbrook Viaduct  
Renewals and Minor Enhancements  
Credit: Paul Tomblin

Issue 145  
16<sup>th</sup> July 2025

Continuous Learning & Improvement Cascade  
Eastern Routes Capital Programmes

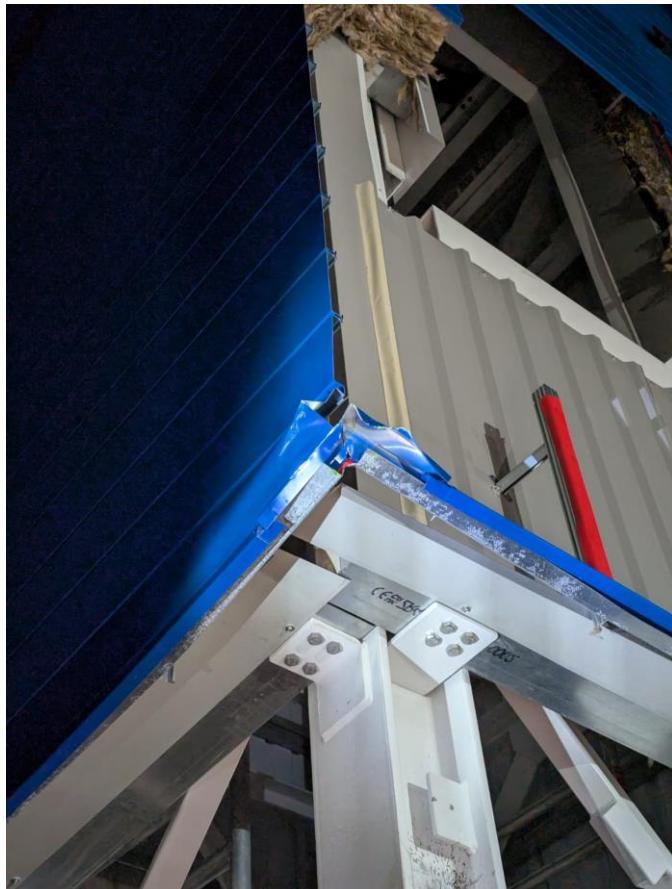
A MEWP was on site and positioned (basket facing south) between the lift shaft and the trestle foundation – it was on site to facilitate the undoing of the lifting points on the top of the lift shaft once the lift shaft had been lowered into position. The MEWP was moved from its parked configuration by a sub-contractor whilst the lift shaft was being positioned on to the holding down bolts.

Once the lift shaft was over the install area, tag lines were used to lower the shaft in position. Due to the restricted access inside the hoarding the contractor couldn't get the pull on the tag line to turn the lift shaft whilst being lowered. A Carver operative decided to get into the MEWP to help turn the lift shaft to assist his colleagues line up the shaft with the bolts on the ground. The tag lines were not able to pull the shaft into the correct position – whilst lowering the load the corner sill of the shaft caught the edge of the MEWP basket causing minor damage during installation.

- A sub-contracted operative used a MEWP for an activity that was not described in the RAMS – Tag lines only should have been used
- The Story site manager should have stopped the works when they deviated from the contractor RAMS
- The Story site manager should have reported to route control and completed internal Story reporting procedures
- Pre-clad lift shaft was used to minimise work on site

- Re-fresher to all Story Site Managers and Supervisors on the requirement to report via Eco-online and how to report – lunch & learn
- Direct management of sub-contractors

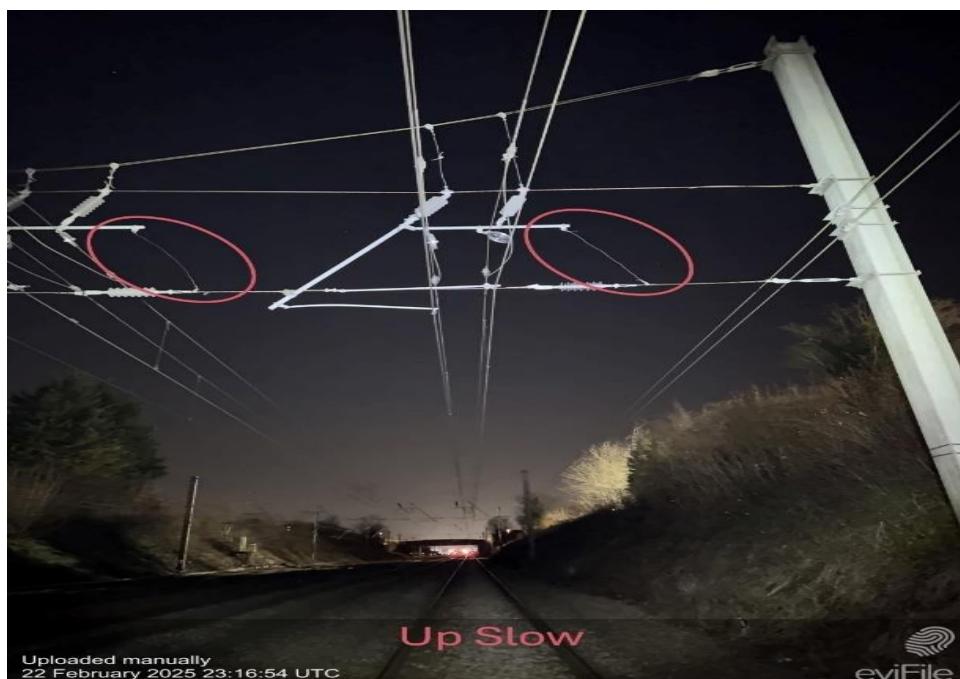
On the 24<sup>th</sup> February 2025 following the cancellation of the Leagrave OLE Form B at 02:11 electrical sections 624 DEF tripped whilst the ECO attempted to re-energise the system.

- Two Nose Droppers had been incorrectly installed by SPL's sub-contractor Pod-Trak
- The Nose Droppers were installed on the wrong side of the insulation on both the Down Slow and Up Slow at structure F50/15.

- The Contractor's Responsible Engineer (CRE) will now operate as an independent entity and will ensure all works are reviewed and approved in real time prior to hand-back.
- The Supervisor and Engineer will jointly review the work to ensure conformity with the approved design. Any deviations will be assessed, escalated through the CRE for acceptance and documented via the Field Change Request (FCR) process.
- The FCR process to be re-briefed.
- SPL will supply a dedicated OLE engineer on site who will review each location to confirm the construction works align to the AFC drawings and the infrastructure is fit for service

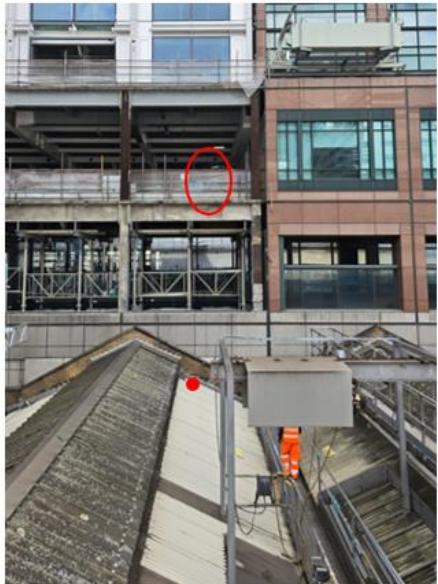
A scaffold tube fell from an adjacent construction site (a third-party developer works), penetrating the aluminium roof at London Liverpool Station and landed in the Morgan Sindall Principal Contractor area during their non-working hours. Damage was caused to both the roof and the Morgan Sindall crash deck.

Scaffold tube fell from red circled area and penetrated roof at red dot

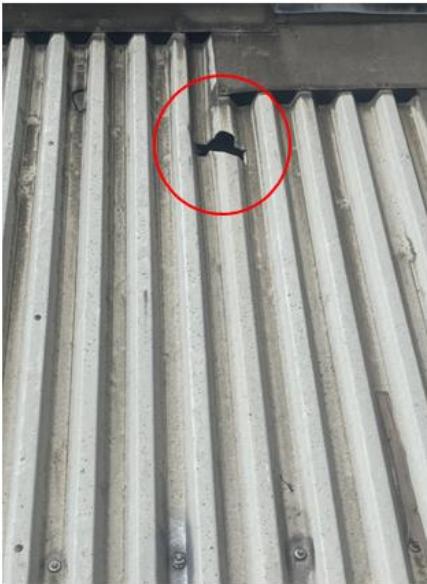
Roof penetration point

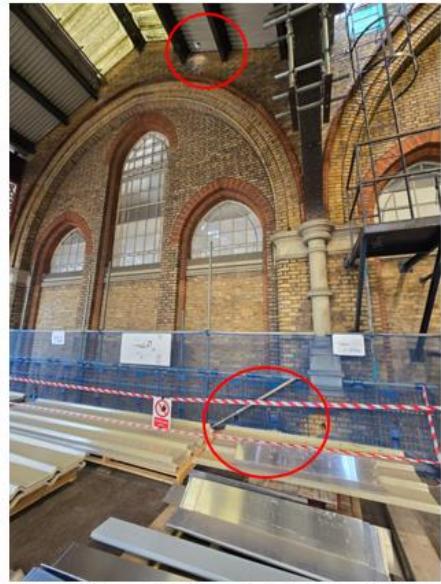
Penetration point (top circle) and scaffold tube landing point on crash deck (bottom circle)

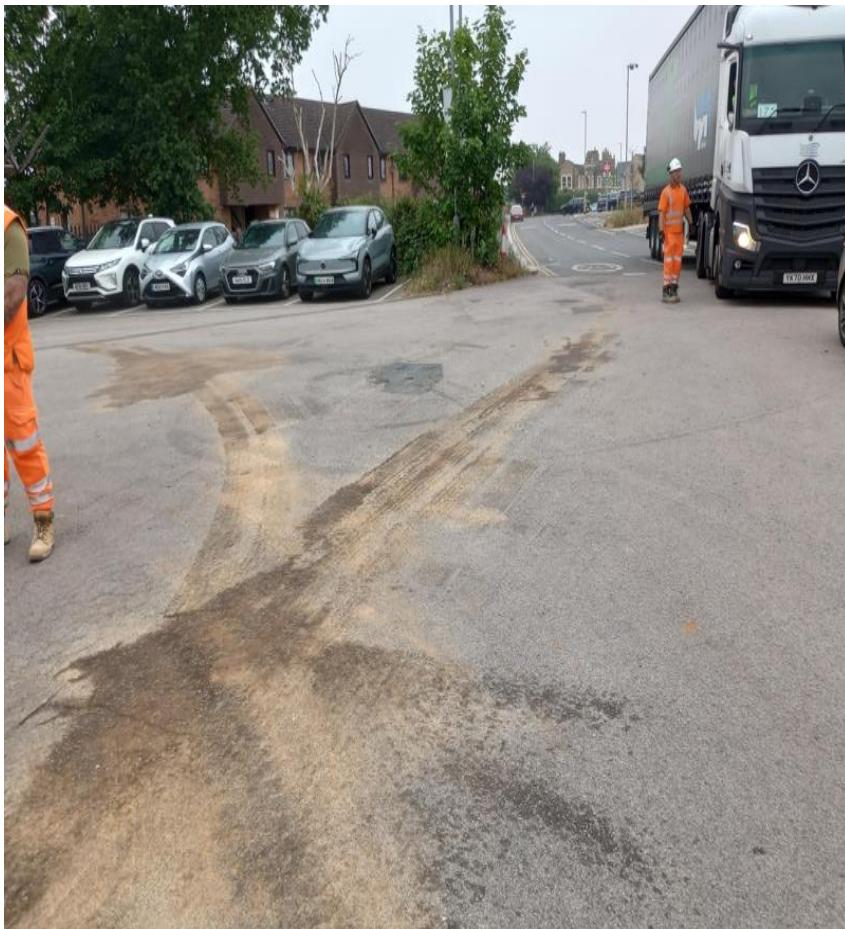
On the 07/07/2025 at approximately 17:00 as the site was shutting down for the day site operative noted that a contractor vehicle which previously been on site was now parked on the public road and had sustained a small oil leak after leaving site.

Small oil leak occurred after leaving site.

Probably due to a burst hose or failed coupling in the hydraulic system.

- In conjunction with the sub-contractor / delivery organisation establish probable cause of the oil leak.
- Ensure environmental spillages are correctly reported immediately in line with the event reporting process and not as Hazard Spotters (Close Calls).

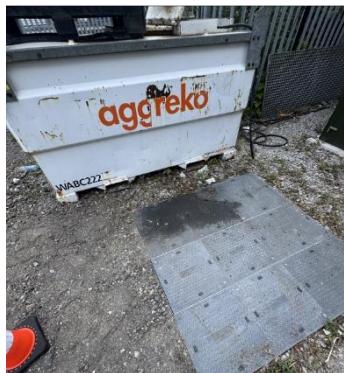
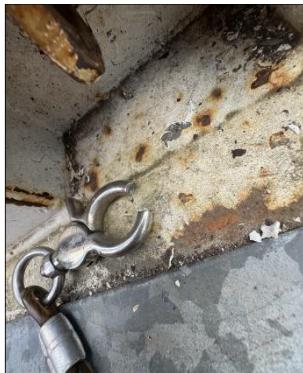
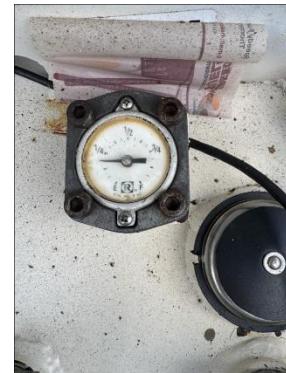
On 11/07/2025 at around 13:15, one of the engineers working on the C3R project attended Shepreth compound to meet Aggreko to top up the fuel bowser for Shepreth DNO. While on site, the engineer discovered that there had been a break in and approximately a 1/4 of a tank of fuel has been stolen.

Photos taken at the time of discovery.

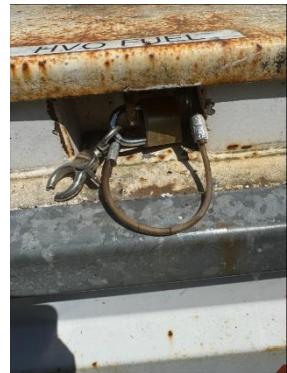
Photo of the action taken to secure the fuel bowser.

The engineer secured the bowser using a small abus lock

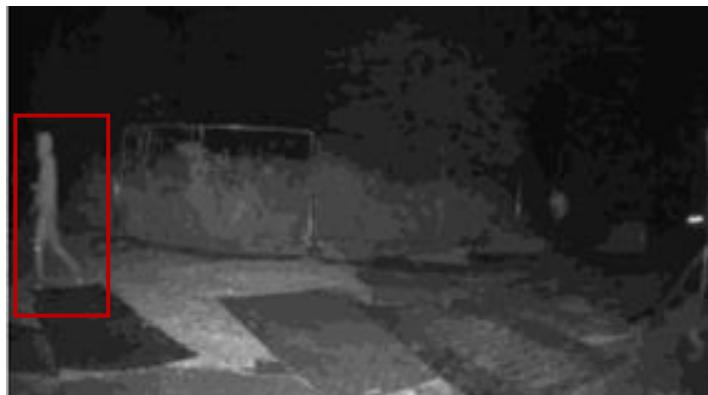
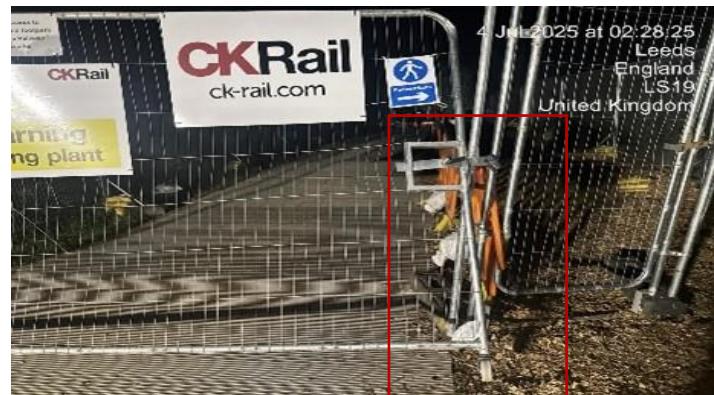
On 04.07.2025. Approximately 01:32hrs, Intruders were reported on the Springs Tunnel site compound. They entered through the main access gate by partially lifting it and crawling underneath (see photo below). The security alarm was raised automatically when it detected the movements of people, and police were called. Approx. At 02:00, police were on site along with the security service response officer, suspecting that intruders could still be on the premises. The police advised the mobile guard to remain outside for safety reasons while they conducted a thorough search and confirmed no individuals were present.

- The project team reviewed the security arrangements on site to ensure that the compound security arrangements were suitable and sufficient.
- Operatives were briefed on the safe storage of tools and equipment in the site compound before leaving the shift.
- Discussed with the police to increase their patrolling on the site location.
- Undertook a company-wide briefing on the site security and safety.

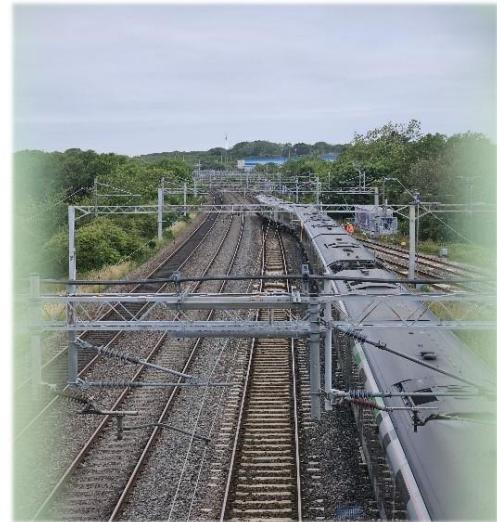
On Thursday 26 June 2025 1Y26 was declared a failure at Bletchley Station on Platform 4 (Up Slow). Due to the nature of the failure the train could no longer be driven from the front (up direction) cab. It was decided to send the train to King's Heath Depot in Northampton as 5Y26.

Denbigh Hall South Junction is a flat junction where the Down and Up Bletchley Lines join the West Coast Main Line Down and Up Slow Lines. The Down Bletchley joins the Down Slow using TK262 which is the designation for combined trailing points (TK262A) on the Down Slow and a Switch Diamond (TK262A/B) on the Up Slow. Switch Diamonds are not intended to allow trains to cross from one line to the other.

It was decided to reverse TK262 A / B / C to cross 5Y26 from the Up Slow to the Down Slow. The route was checked by a second signaller and verified by the Shift Signaller Manager (SSM) in Rugby SCC. **Neither the controlling signaller, or the signaller who checked the route and the SSM, realised that the move could not be made using a switch diamond.**

The controlling signaller gave instructions to the driver of 5Y26 to make the wrong direction move. At 12:29 the driver of 5Y26 made a GSM-R REC call to advise the signaller that the train had derailed.
