# CLIC

## *Safety Events Digest*

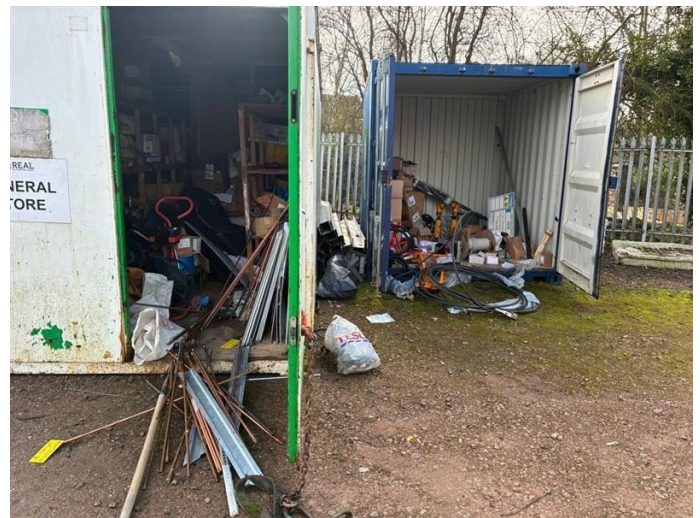
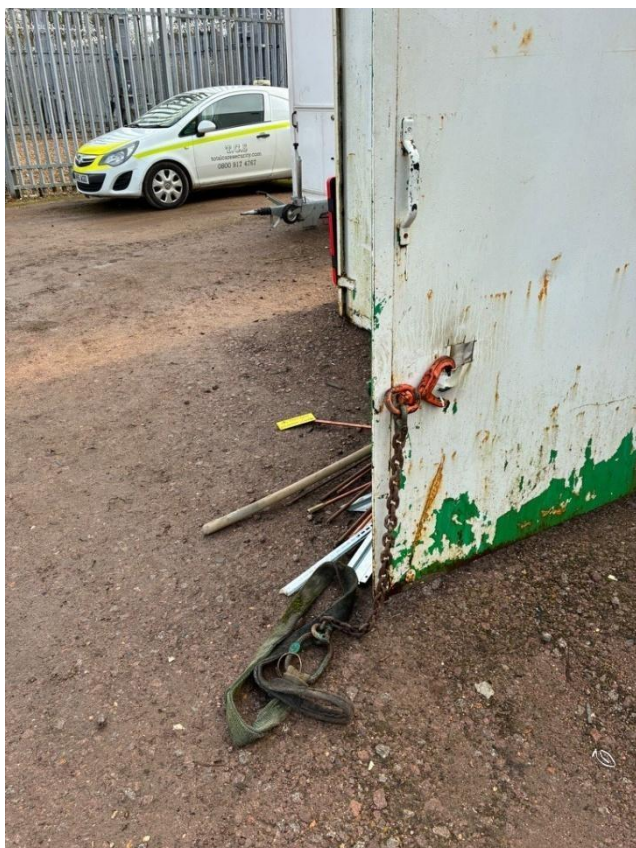
A trespass and theft occurred at Langley SATS in the early hours of 25 February 2026. Unknown individuals gained access to the site, forced entry into containers, and removed a range of materials and tools. The incident resulted in both theft and damage to site infrastructure.

- Copper tape
- Cembre crimp tool
- Drills
- Various fixings
- Damage to CT equipment
- Multiple containers broken into

British Transport Police notified and crime reference obtained

MOM applied a new XJK 859 padlock to secure the access gate at 05:15

- **Security Review:** All site managers to review current security arrangements, including container locks, lighting, CCTV coverage, and perimeter integrity.
- **Incident Reporting:** Any further information, suspicious activity, or similar incidents must be reported immediately to the local manager and security team.

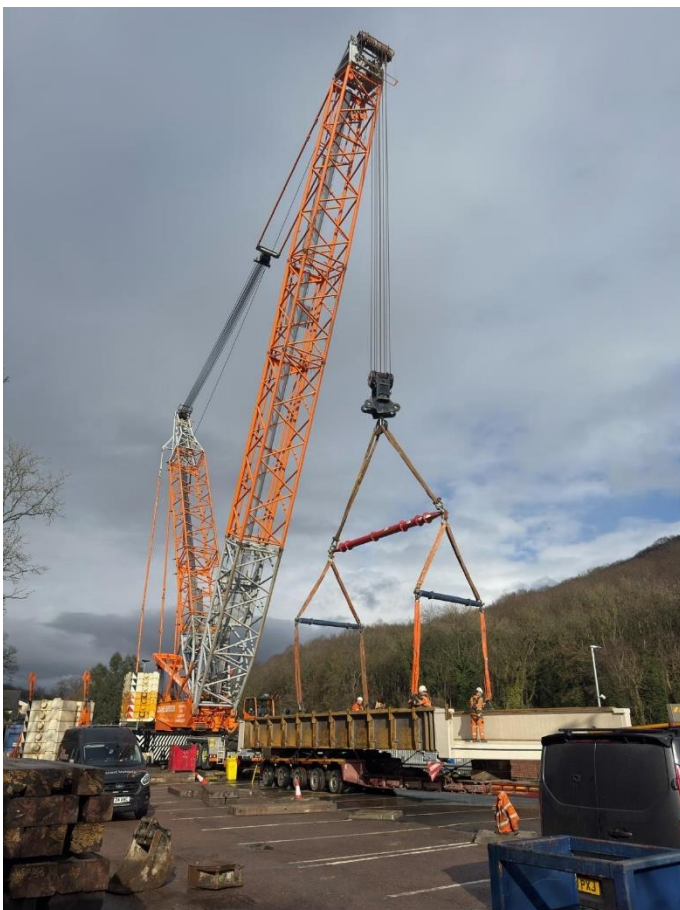
- A new bridge deck was planned to arrive at the Story compound in the station car park during the day shift and remain on transport. The load was planned to be lifted from the transport into its proposed temporary location in the wideway during the following night shift.
- During the day shift, the new bridge deck was removed from the transport and lowered towards the ground in the car park. The load was held by the crane with timber packers placed underneath to prevent swaying. There was no temporary works design for landing the deck on the ground in the car park.
- During the night shift, the new bridge deck was lifted into its proposed temporary location in the wideway.

- Car park surfacing checked to ensure no signs of damage from taking potential partial deck load

- Investigate decision making for removing the deck from transport
- Assess any risks imported by deviating from plan

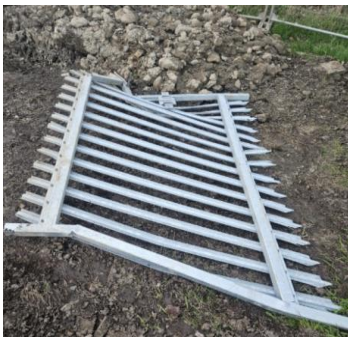
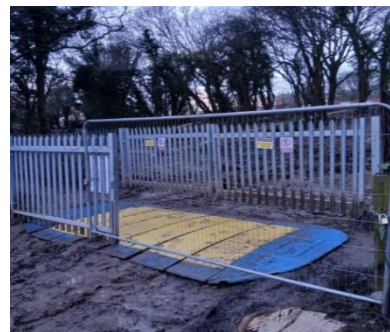
During a routine movement of piles, the excavator travelled through the temporary gates under control of a designated banksman, with a gateman positioned at the footpath to monitor for any public access. Weather conditions included notable wind, which is believed to have caught the gate leaf. This caused the gate to swing shut unexpectedly toward the machine.

The gate became caught in the excavator tracks, resulting in damage to the gate.

High wind & no latches to secure gate from unexpected movements.

Inspection of all temporary gates on site to ensure they are adequately secured against wind loading and unintentional movement. Review of gate-retention methods, including the potential installation of latches, drop bolts, or temporary restraints to prevent recurrence.

Briefing to all plant operators, banksmen, and gatemen to reinforce the need to visually confirm gate positions before plant passes through.

A Toolbox talk to be issued to the team & replacement of the damaged gate to reinstate full segregation as soon as possible.

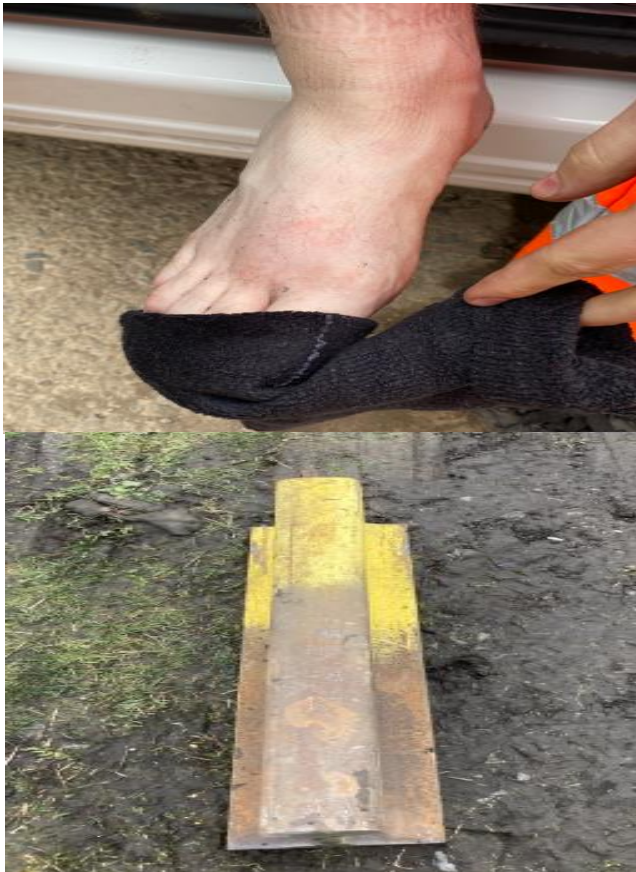
- MOS under instruction was moving an offcut of rail from the cess to a rail mounted trolley.
- The offcut of rail was circa 1 meter in length and was being carried by the IP and one other operative.
- The offcut of rail slipped from the IPs hand onto a sleeper end and then rolled onto the IPs right boot.

- Reported to on call.
- IP attended A&E – Xray's taken, no broken bones only slight bruising was sustained.

- Level 1 investigation will be completed to establish the facts and any improvements that can be done in the future.
- MOS has confirmed they are fit to attend their next planned shift.

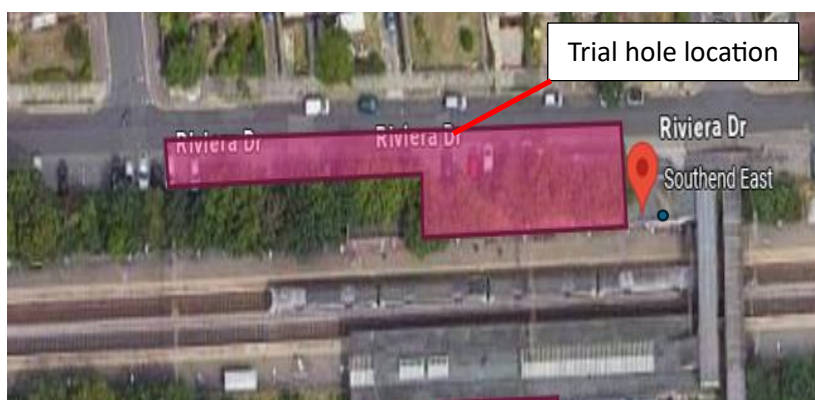
Site Compound

Cadent Gas then excavated the loose material and used a probe in the surrounding ground to locate the leak. They then carried out further excavation all the way across to the mains and discovered a domestic supply pipe that had become loose/disconnected at the joint with the mains, at a depth of app 1100mm. This domestic supply was not shown on the utilities CAD drawing and not picked up during CAT scanning as it is 25mm poly.

TBC. It is not known at this stage if the trial works caused damage to the domestic supply pipe. BPH state that no services were encountered at any point during excavation works

Works stopped  
Service Owner attended and is carrying out repair

- Excavation works on hold
- Investigation continuing Monday 09/03/26

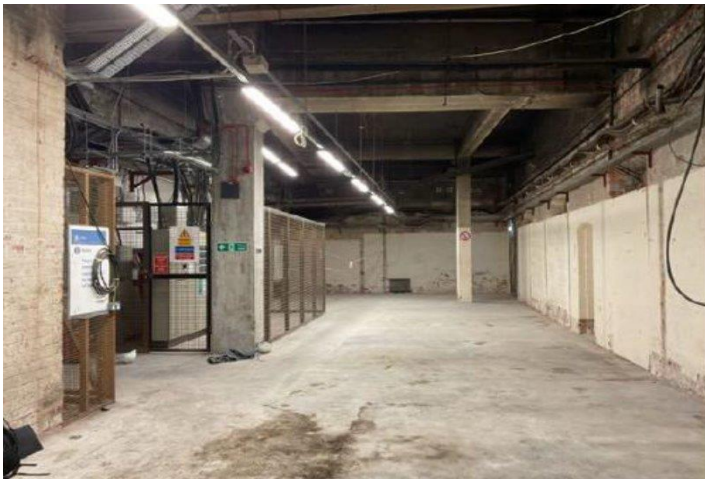
- Between 1 and 3 December 2025, intrusive survey works took place in the basement room. The works involved breaking out concrete from steel beams to expose the steelwork beneath.

- On 10 December 2025, an additional room was entered and worked in to carry out core holes.
- The R&D survey results for the basement room were received by BAM on 11 December 2025. The survey confirmed the presence of asbestos in some areas of the rooms in question.

- The requirement to complete and review targeted R&D asbestos surveys prior to intrusive works was recognised; however, this requirement was not fully embedded within project planning and sequencing controls.
- Asbestos hazards were identified within pre-construction information. However, these requirements were not clearly translated into verification controls within the Works Package Plan(WPP) and Task briefs
- Although asbestos related information was available to multiple project roles, responsibility for confirming R&D survey completion prior to intrusive works was not clearly defined.

- All works paused and full area being surveyed for presence of asbestos
- All site team staff undertaken asbestos awareness training
- Briefing given to whole project team on incident and lessons learnt
- Asbestos action tracker created
- Asbestos Hold points added to WPP/TB
- Designated person appointed to manage asbestos matters

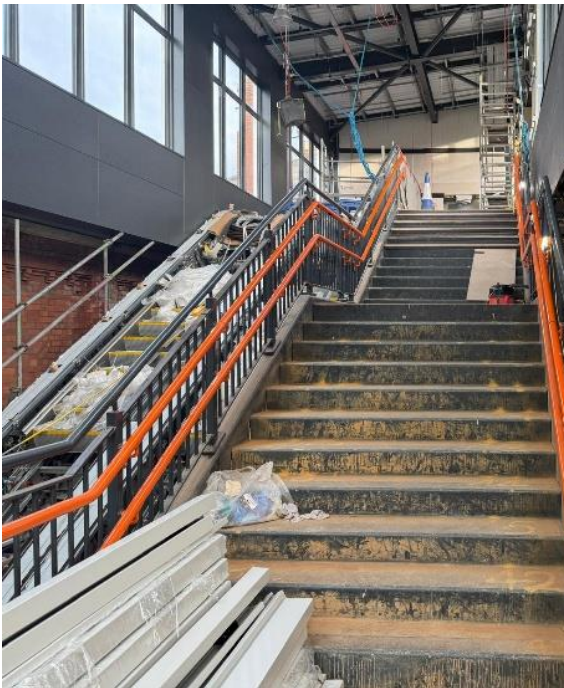
Ceiling installation above the escalator has been carried out within the existing station during back shift. Rope access was used to install the ceiling units. The ceiling units were passed to the rope access guys by a sub-contractor (SC) supervisor. The ceiling units were stored on one of the landings of the stair case. When the supervisor walked up the stairs in the existing station, they lost their footing where there is a tread difference (point where new treads have been laid over Christmas, resulting in difference in stair riser). They fell on their hand. This happened at 20:40 but they carried on working for the full shift – the BAM supervisor checked on them throughout the shift if they wanted to get it checked but they declined. They attended hospital for a check-up after the shift.

The difference in risers on the stairs had been highlighted as a risk but the identified actions to resolve had not been completed.

- Not all the new treads had been delivered but the site team decided to proceed with what they had, leaving a change in height between steps.
- No signage was put out to warn staff of the change in height
- No briefing to staff to warn of the difference in height

- Supervisors were briefed on the incident
- Area was cordoned off until completion
- Daily checks are carried out of all walkways prior to works allowed to start each day
