West Hampstead Signalling & Telecommunications Project  
Renewals & Minor Enhancements

Issue 092  
26<sup>th</sup> June 2024

Continuous Learning & Improvement Cascade  
Capital Delivery Eastern Region

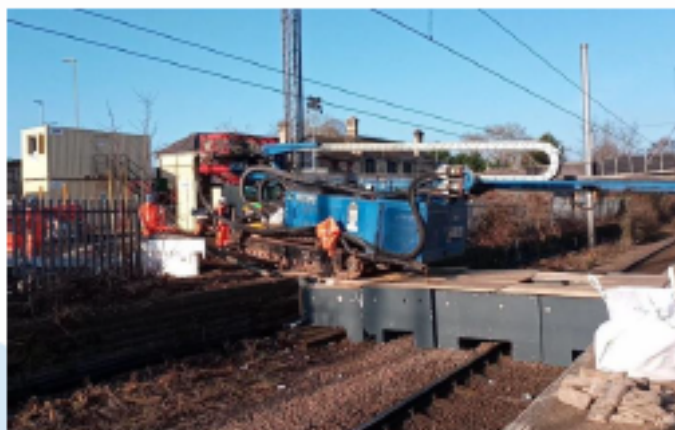
Structural polystyrene blocks were designed and installed to allow machinery and staff to access/egress all platforms at Biggleswade Station during a blockade.

Whilst attempting to move a piling rig across one of the bridges, a crack was observed. The piling rig was reversed off the bridge deck.

A telehandler also drove onto the second bridge and dislodged a coping stone.

- 1) Critical design inputs were not provided in time meaning that the design/check/assure process was rushed.
- 2) The bridge wasn't built or installed as per the design due to site difficulties and lack of experience in using this type of system.
- 3) Different bases used to those that were on the initial design in the mistaken belief that it would be ok, as the same system had been used previously elsewhere to transport piling rigs.
- 4) Narrower width base used creating greater pressure on each geofoam block.
- 5) Temporary works checks not completed with full diligence.
- 6) Leadership on site had a desire to 'get the job done.'
- 7) On call process not followed.

- What measure can be taken on your project to ensure temporary works are always built as per the design?
- How can we ensure that our people always Take Five?
- At what point should you contact the On Call Manager?

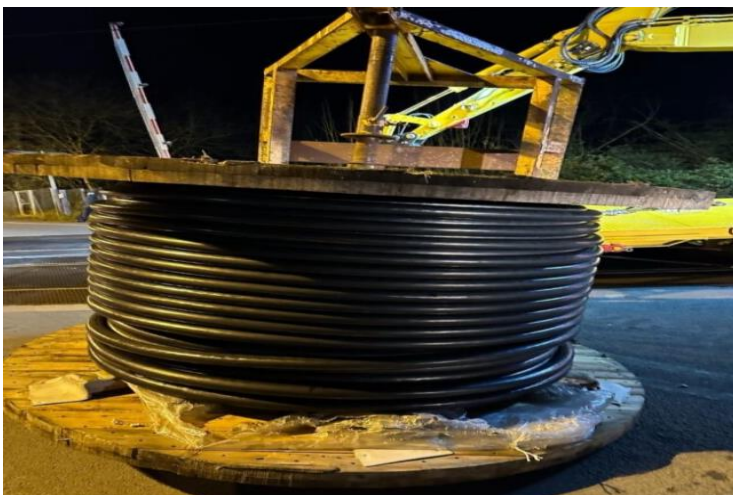
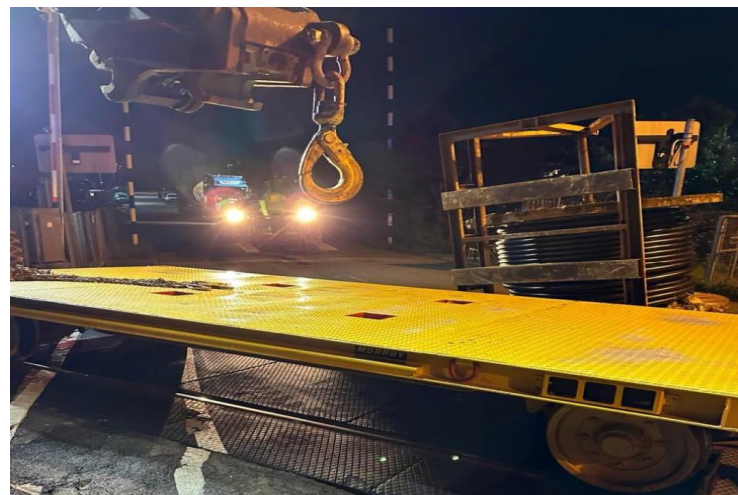
The RRV moved back into position on the level crossing to allow for the equipment to be secured to the trailer bed at the level crossing. As this was done, the driver of the RRV made an uninstructed move of the machine arm and it came into contact with the trailer. This caused the A Frame/Spool to slide across the trailer and fall to the ground - narrowly missing an operative who had entered the exclusion zone without the crane controller's permission.

- PSU Alliance have prohibited the use of 'A' Frames with skids on the underside of the frame.
- Loading sequence to be amended in Safe System of Work procedure.

- Equipment, such as A-Frames, to be suitable for intended task.
- Securely strap A Frames to the bed of the trailer as per NR-NR-L2-RMVP-0200-P509-ISSUE-4
- Exclusion zones must always be maintained and managed.
- Ensure competence is checked and the activities are understood by those involved.
- Ensure machine movements are pre-planned and authorised by the crane controller.
- All persons involved in the task must be fully briefed and understand the plan.
- Deviation from the plan: Stop works, re-plan the work & get authority for the plan & implement the plan.

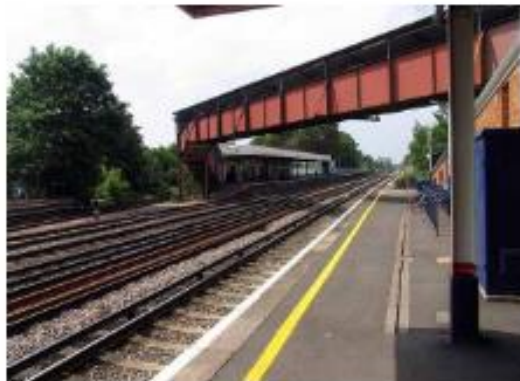
At 02:45 on 29/05/2024, a Road Rail Vehicle (RRV) transited through a possession on an adjacent line to a rail delivery train (RDT) being set up to. An RDT operative had to jump out of the way to avoid being struck by the RRV.

- Works in a neighbouring worksite, involving the RRV, had been curtailed.
- The RRV movement took place without prior notification to the RDT team.
- No warning by the RRV operator.
- No Machine Controller accompanying the movement, they followed several minutes later.
- The RRV allegedly travelled at a greater than 5mph.

- Rail deliveries needs to be planned and executed in accordance with: Standard [NR/L2/SCO/315](#) and Task Risk Control Sheet [NR/L3/MTC/RCS0216/MAT04](#).
- Are all staff who are expected to oversee activities in worksites and possessions, involved in the planning of the works? This is an ideal opportunity to communicate the requirements of RDT worksites.
- Do deconfliction activities identify how neighbouring worksites might impact on each other eg if there is a late change? In this case the RRV egress point was through the RDT worksite.
- How is the communication of change led, controlled and understanding checked?

- Do briefings prior to starting work outline the risks or restrictions within the possession?
- How do teams in neighbouring worksites, collaborate to manage risks to each other from late changes?
