# CLIC

Issue 155 – 24<sup>th</sup> September 2025

## Fishplates found missing following track inspection

**Ref:** NRB25-03

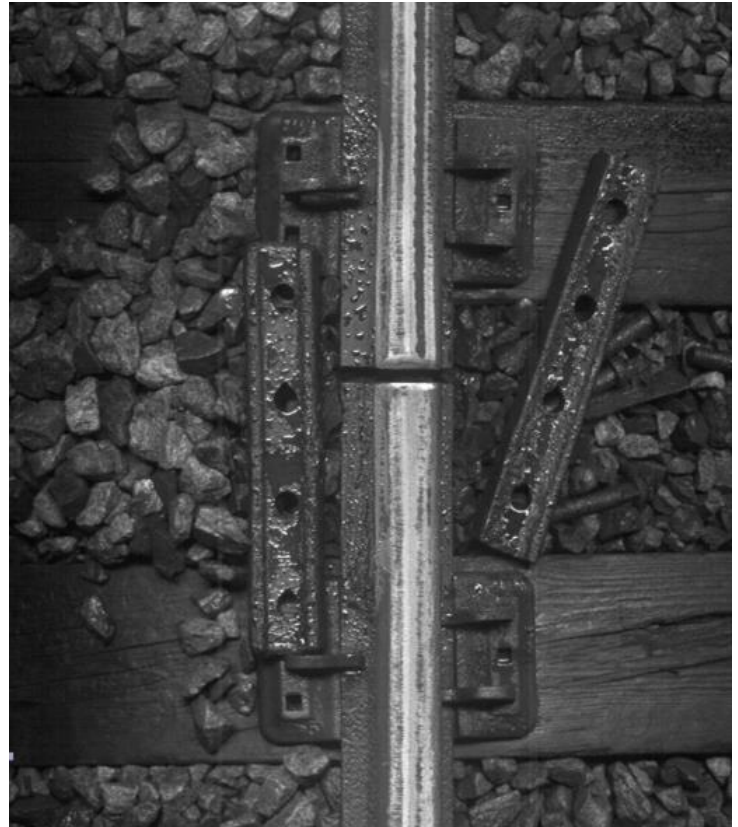
On Thursday 4 September a review of data gathered from an Ultrasonic Test Unit train identified a track joint with all bolts and fishplates detached from the rail at Park South on the Cumbrian Coastline.

A Basic Visual Inspection (BVI) of the track was completed at this location on 20th August in a routine midweek night line blockage. The BVI identified a cracked fishplate at a joint adjacent to this one.

Due to difficulties in installing the replacement fishplates, the fishplates on the adjacent joint were removed to allow some movement of the rail. For reasons not yet understood, these fishplates were not reinstalled before the line blockage was handed back.

Actions were taken immediately to protect the line until repairs were carried out.

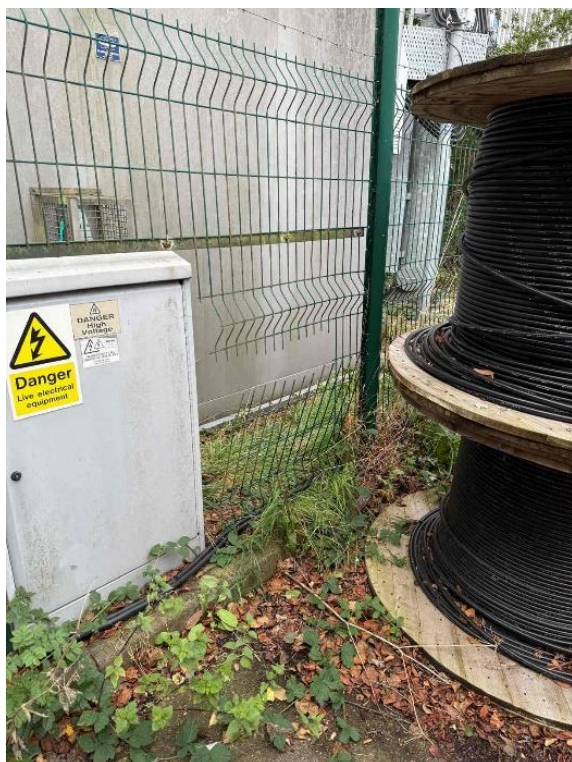
On the morning of 18 September 2025 at approximately 08:50, Alstom's security team conducted a routine visual inspection of the boundary fence surrounding the C3R Stores site. During the inspection, a section of fencing belonging to a neighbouring compound was observed to have been cut.

A neighbouring compound fence has been cut to allow for possible entry.

The Property owner was contacted to allow repair to the perimeter fencing.

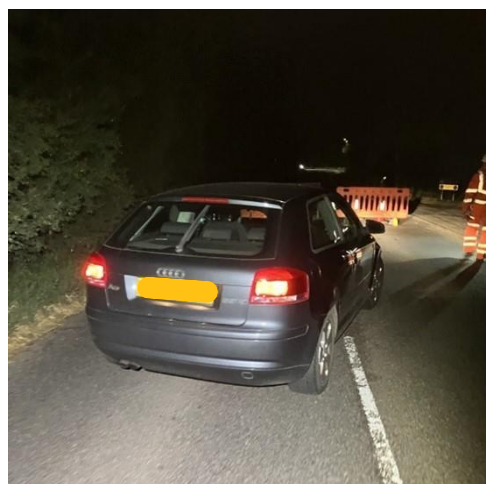
At approximately 23:03, during the start of the ground investigation shift on Friday 5<sup>th</sup> September, a vehicle breached the road closure implemented by the traffic management (TM) company. Earlier that evening, at around 22:50, the TM team had installed “Road Closed” signage, Chapter 8 barriers, and cones on both sides of the crossing to facilitate the safe execution of the investigation works. Following the setup, the TM crew proceeded to drive the designated diversion route, placing appropriate signage to guide motorists. During this process, a black Audi A3 bypassed the closure by driving through a narrow gap in the barriers. The vehicle stopped on the far side of the closure and waited for a staff member to move cones to allow it to continue. Despite verbal warnings and attempts to stop the driver, they ignored instructions and showed no concern for having violated the Highway Code. Fortunately, at the time of the incident, all personnel were gathered in the Melton Station car park for a pre-shift briefing, and no staff or pedestrians were exposed to immediate danger.

*Car involved*

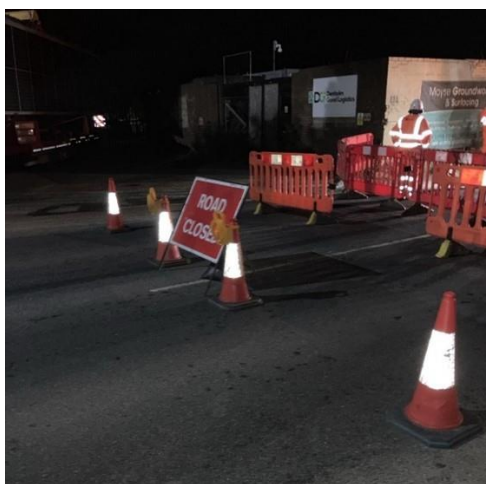
*Road closure on western approach taken after the incident once more chapter 8 barriers had been installed.*

- There was a small gap in the road closure that a vehicle could get through
- The diversionary signage was not installed before the road closure was implemented.

- Additional chapter 8 barriers were installed to fill any gaps in the road closure
- Staff were briefed to remain vigilant throughout the shift.
- A close call was raised

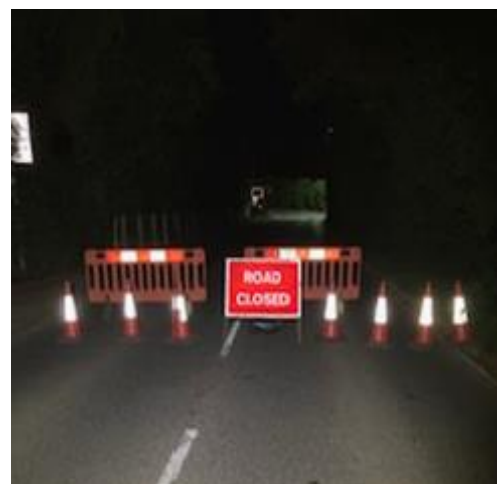
*Road closure on eastern approach taken after the incident.*

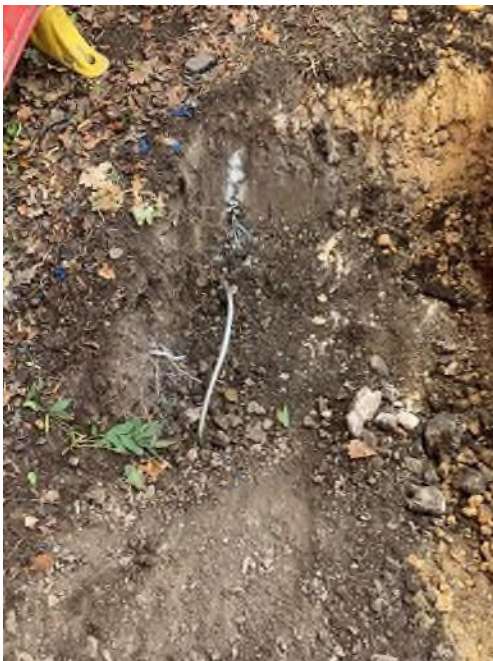
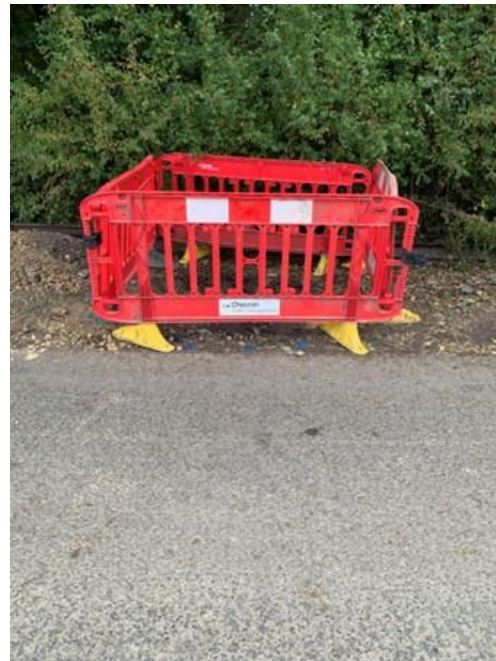
Whilst undertaking excavation works off the verge of a B road for new highway signage near Thorpe Level Crossing (John Croft Lane), an excavator struck an underground cable.

The BT cable was located approximately 400mm below ground level, with no warning tape or sand bedding present to aid in identification.

- The excavator struck a BT cable located approximately 400mm below ground level.
- The cable had no warning tape or sand bedding to aid identification.
- A BT engineer attended site and confirmed the cable is redundant.
- A valid permit to break ground had been issued.
- A CAT and Genny were present on site.

- The site team secured the area.
- BT was informed and has since attended site, confirming the cable is redundant and poses no further risk to residents or the operational railway.
- Highways excavation works were suspended pending completion of the investigation.

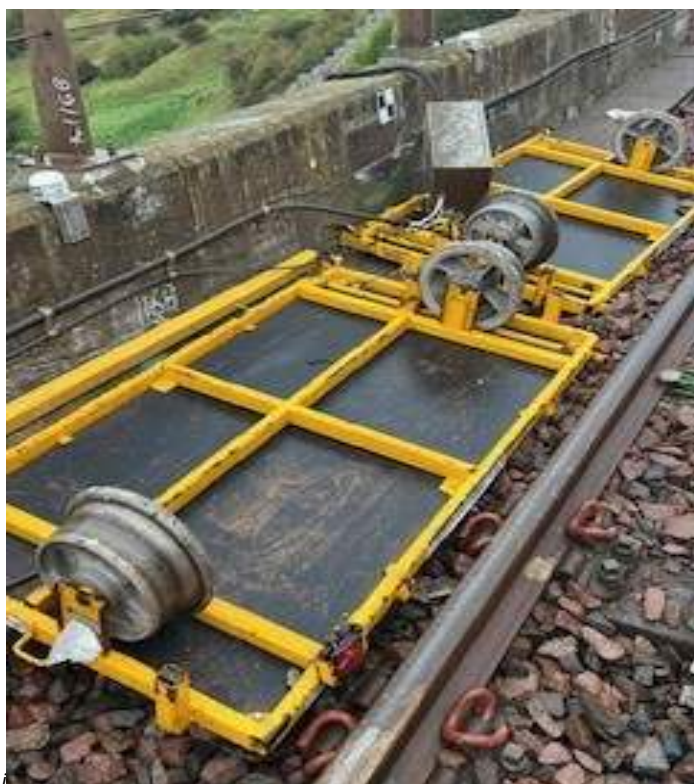
- At around 0900 Saturday the day shift supervisor discovered that an E&P junction box and some cables attached to the Down Parapet wall had been damaged.
- It appears that a track trolley that had been left on the viaduct & has been dragged approximately 10m along the top of the trough route by an engineering train which was travelling at 5mph.
- Damage to the trolley was minimal and there are some superficial scratch marks to the sandstone parapet.
- The trolley had been used overnight to position a generator associated with structure monitoring equipment.

Track Trolleys located in the cess above and the damage caused

- Damage assessed by E&P Supervisor.
- L3 on call informed.
- Close call and fast facts raised.
- All track trolleys and tools removed from the bridge and returned to a position of safety in the cess located

- Level 1 Investigation underway
- Repairs to be planned during next possession.
- Interviews and witness statements with ES, COSS and the train driver to be taken.

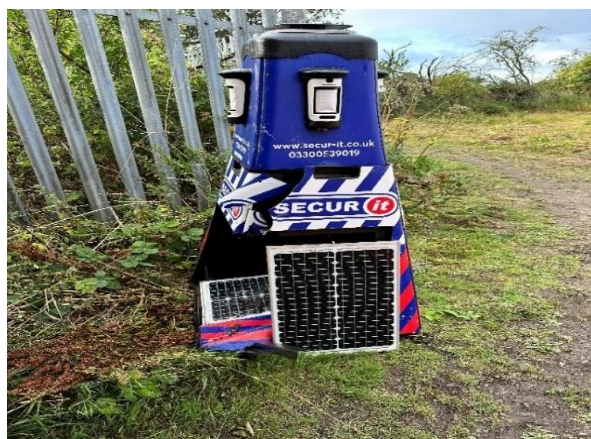
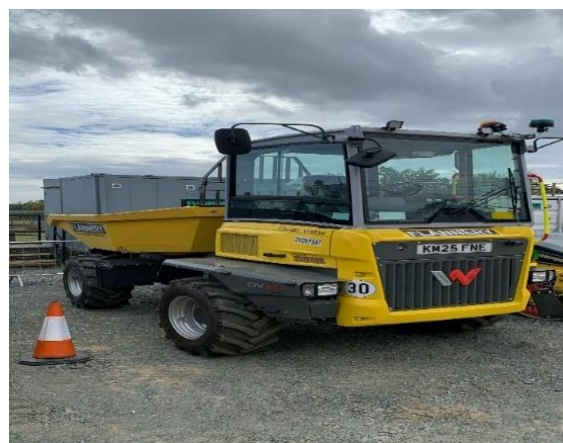
On 07.08.2025. At the beginning of the shift, approximately 08:05 hours, at the site compound, the dumper driver walked from the rear of the vehicle to enter the vehicle cab. Upon entering the vehicle cab, the operative proceeded to drive forward and as he did, the dumper came in contact with a Darlek CCTV positioned close to the vehicle in the compound.

- The dumper driver did not undertake the pre-use walk around checks before moving the dumper.
- As a result, the dumper driver failed to notice the Darlek CCTV, which was positioned close to the vehicles parked in the site compound.
- No Banksman was present at the time of the incident.

- Work stopped immediately – The site manager delivered a Toolbox Talk to all operatives on safe vehicle movements within the compound.
- Banksman support introduced – A banksman with a Dect comms system is now required for all vehicle movements in the compound.
- Rebrief on reporting process – The project team were reminded of the correct procedure for incident reporting.
- Repositioning of CCTV – The Darlek CCTV unit was moved to a safer location within the compound, clear of vehicle movement routes and potential damage.
