# CLIC

**LNER**  
LONDON NORTH EASTERN RAILWAY  
Issue 116  
11th December 2024

Continuous Learning & Improvement Cascade  
Eastern Routes Capital Programmes

## Northumberland Park Mine Remediation Works – Case study

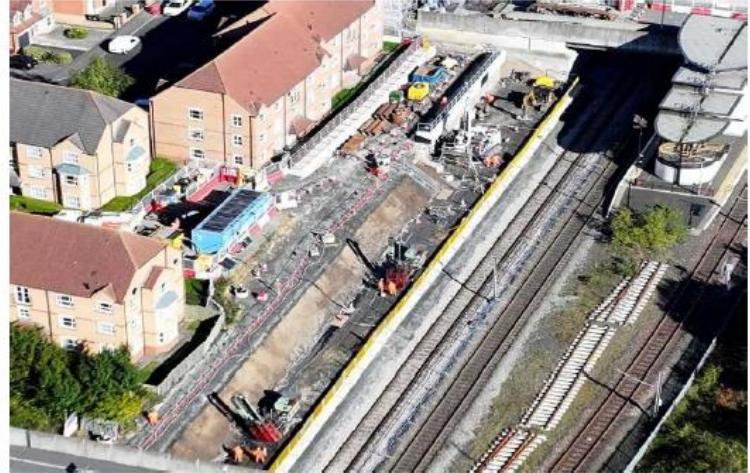
Figure 1: Northumberland Park Site

- Proposed Northumberland Park Station is located adjacent to Northumberland Park Nexus Metro station.
- The new station is constructed within the rail corridor, with poses greater Health and Safety risks as well as two over bridges and situated on an embankment. This poses great logistical challenges for the work. Please see figure 1.
- As part of planning permissions the new permanent construction area must be fully treated to allow construction of new station.
- There are several stakeholders involved within the construction including local residents, Network Rail, the Coal Authority, Nexus, Northumberland County Council and North Tyneside.

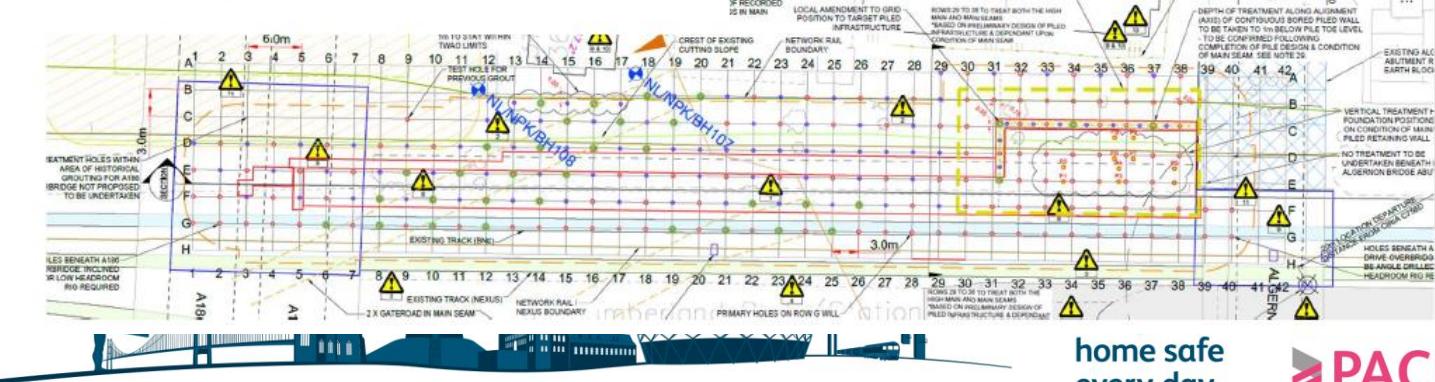
- Designers specified a 6m x 6m drilling grid detailing a series of primary and secondary holes to be drilled and treated, as shown in figure 2. Perimeter wall created to contain grout in areas with high grout takes and gravel added where required.
- Lane closures were utilised on the A186 to create a grout batching plant
- A F002/F003 NwR approved working platform was constructed for the drilling rigs to be situated.
- Typically, two rigs were working continuously with ALO restrictions in place.
- Approx. 3000tns of grout as been 'pumped' beneath track to treat voids.

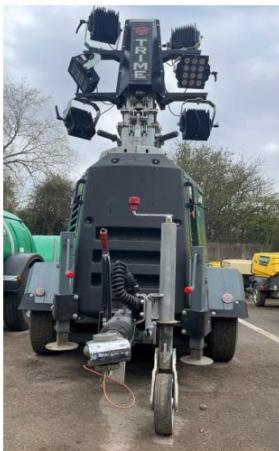
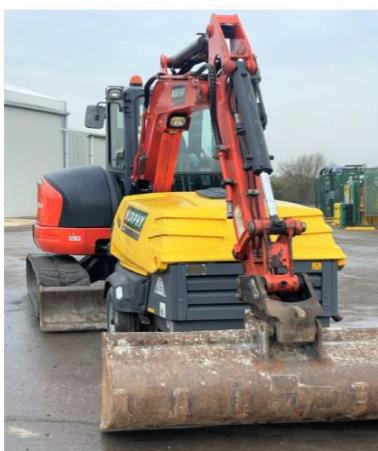
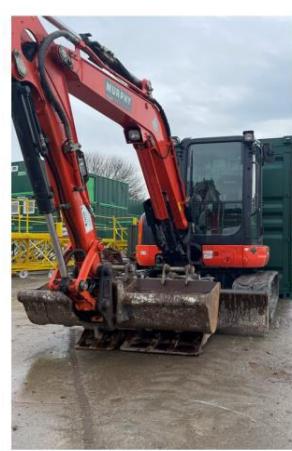
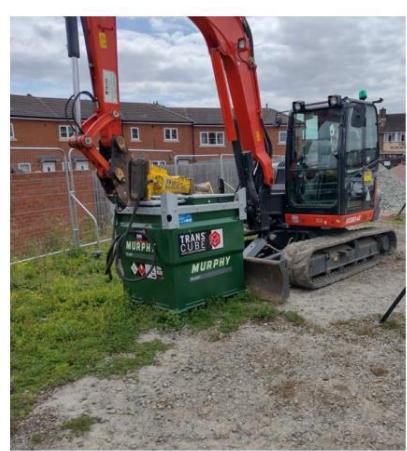
Fit tow hitch locks to all towable plant & equipment and muster equipment together.

Place plant & machinery in front of containers & stores. Use excavators to secure fuel bowsers

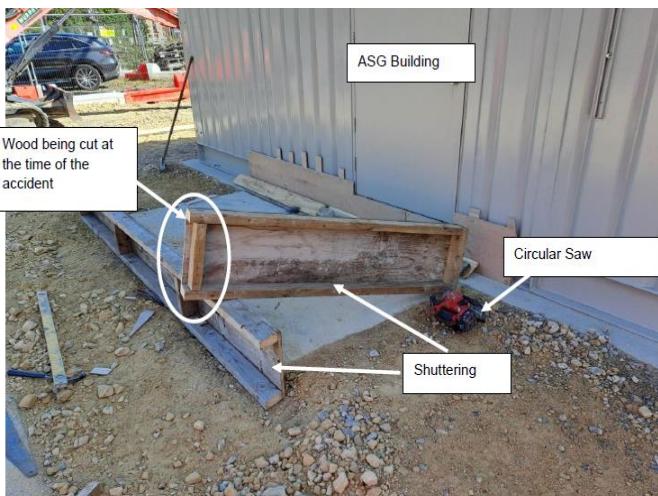
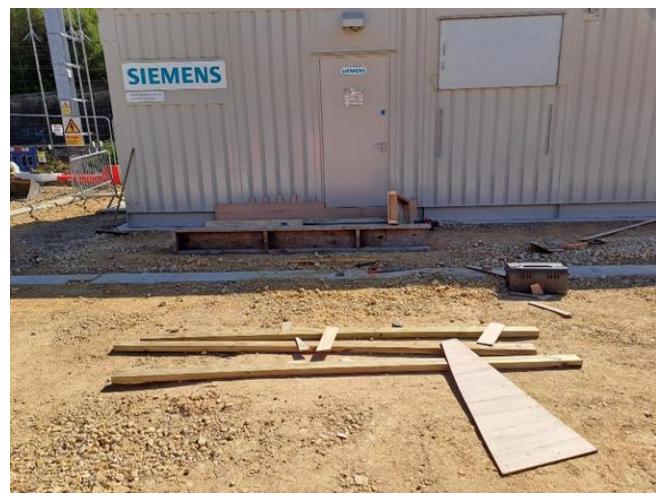
On the morning of the 3rd of September 2024, soon after commencing work on the timber shuttering for the access steps to a container in the compound, a Joiner severed the tip of a finger and cut another finger of the left hand, whilst cutting wood shuttering using a circular saw.

*Images of the work area at the time of the injury*

- The safety requirements for all tools must be included in the Task Brief and risk assessed, and approved before use
- Follow the manufacturers instruction manual, including: the provision of a stable base and the item being cut to be fixed in position
- Wear the PPE identified in the risk assessment
- Complete pre-use safety checks, including guarding
- Do not reach over a moving blade and maintain a solid stance with the wide base to ensure balance
- Both hands should be holding the tool
