# CLIC

Hitchin Maintenance Delivery Unit Project  
Renewals and Minor Enhancements Portfolio

Issue 140  
11th June 2025

Continuous Learning & Improvement Cascade  
Capital Delivery Eastern Region

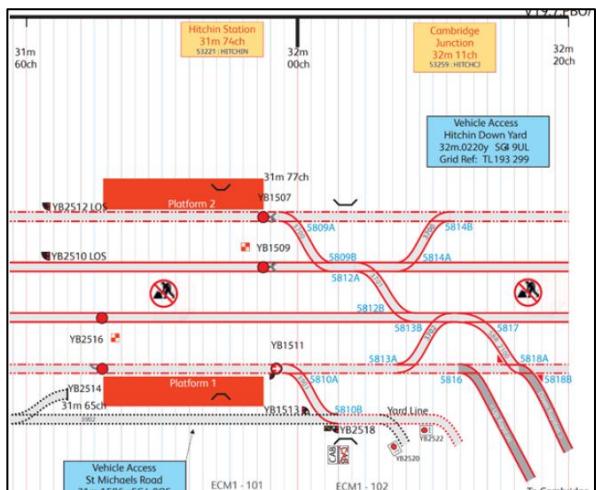
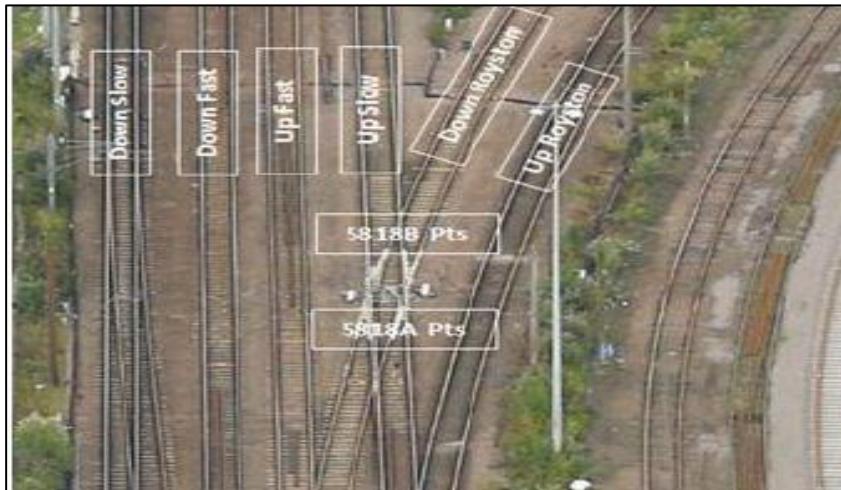
A train derailment took place on Saturday 25<sup>th</sup> January during track renewals work at Wymondley whilst crossing over from the Up Slow to the Up Fast within the worksite. During the move, both front axles derailed on 5818A points & the driver immediately brought the train to a stop.

5818A points are part of a switch diamond crossing that can only facilitate a move from the Up Fast to the Down Royston. It is not possible to make a move from the Up Slow to the Up Fast through this crossing. The team failed to recognise this both in the planning stage & on-site therefore making a move which caused the train to derail.

Photos: Location of 5818A on East Coast Delivery Manager Peterborough line diagram and aerial screenshot.

- A knowledge gap was identified amongst the planning and delivery teams on how to identify different types of Switches and Crossing units.
- Line diagrams were updated to make it clear that 5818A and 5818B are part of a switch diamond assembly for future reference.
- Additional training was required for the planning and delivery teams on identifying and understanding different types of Switches and Crossing units.
- All planned train moves within a worksite over Switches and Crossing units to be reviewed by the Area Possessions Coordinator at the planning stage.
- Checks on engineering train movements within a worksite to be formalised with the local operations manager and added to the stage gate reviews.

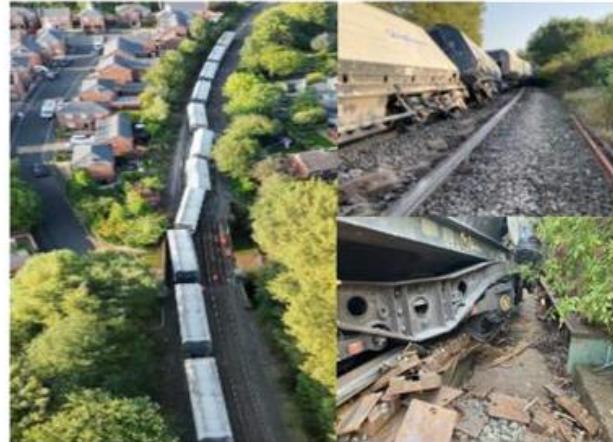
At around 11:25 on 6 September 2024, a freight train travelling between Peak Forest and Salford derailed as it passed over Sidmouth Street bridge in Audenshaw, Manchester. The train was made up of 2 class 66 locomotives and 24 wagons fully loaded with aggregate. The 2 locomotives and the leading 10 wagons passed safely over the bridge, but the following 9 wagons derailed, with the remaining wagons coming to a stand on the bridge itself. No injuries were caused as a result of the derailment but substantial damage was caused to railway infrastructure and some of the wagons.

The track over Sidmouth Street underbridge No. 3 is supported by a Longitudinal Timber Bearer System (LBS) and has a sub 800m radius curve.

Investigations to date suggest that the derailment was caused by gauge spread of the track which occurred when the baseplate chair screws sheared and broke.

- The chair screws in the baseplates were the wrong type. For hardwood timbers they should have been high tensile screws (marked as HT) as per NR/L2/TRK/3038.

- The chair screws used were too short for the depth of packing between the baseplate and the timbers. Screws marked AS had been fitted which are 160mm long (6 5/16 inch). They should have been LSA screws as these are 206mm long (8 3/8 inch),

SIN220 "Managing Lateral Forces on Sub 800m Longitudinal Bearer Systems" was issued on 06 December 2024 which requires the inspection of the type of chair screws and depth of packing to ensure any failed, ineffective or non-compliant screws are replaced.
