CLIC

Issue 144
09 July 2025

Continuous Learning & Improvement Cascade
Eastern Routes Capital Programmes

Shared Learning

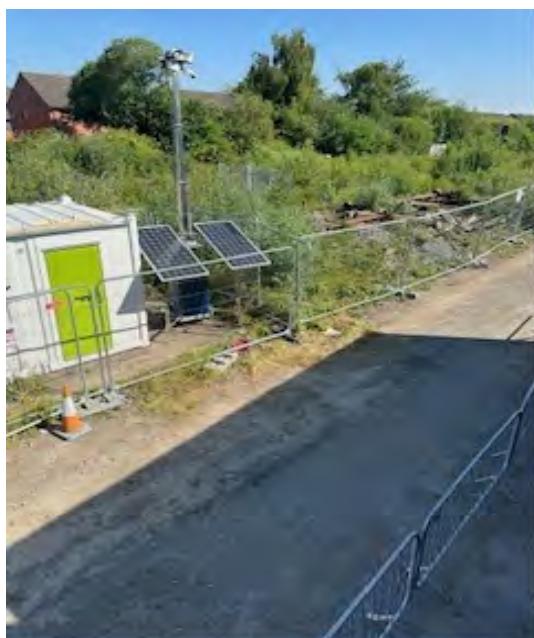
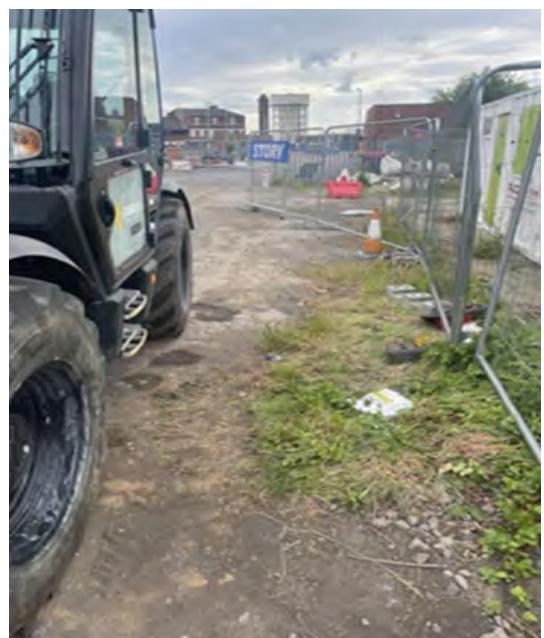
Whilst reinstating the dwarf wall on the North subway the dumper driver tried to pass the stationary telehandler whilst it was parked in the site compound. The mini dumper hit the door of the telehandler causing damage to the glass panel on the door. The glass remained intact although it was damaged

- Dumper driver did not hold competency to drive the dumper truck
- Inadequate sub-contractor site supervision - the driver of the dumper was the sub-contractor's supervisor
- Competent dumper driver was available on shift but was not used
- Non-adherence to the task brief that required a banksman to be in place while moving material from the works area to the compound
- No dynamic risk assessment undertaken – moving the telehandler would have kept the traffic route within the compound clear and free from obstacles

- Story to directly supervise all contractor activities
- Task brief refreshers given to everybody on site

- Only operate plant which you are competent and certificated to move
- Increase direct supervision of sub-contractor activities
- Review of sub-contractor performance and feedback to procurement to update preferred supplier list

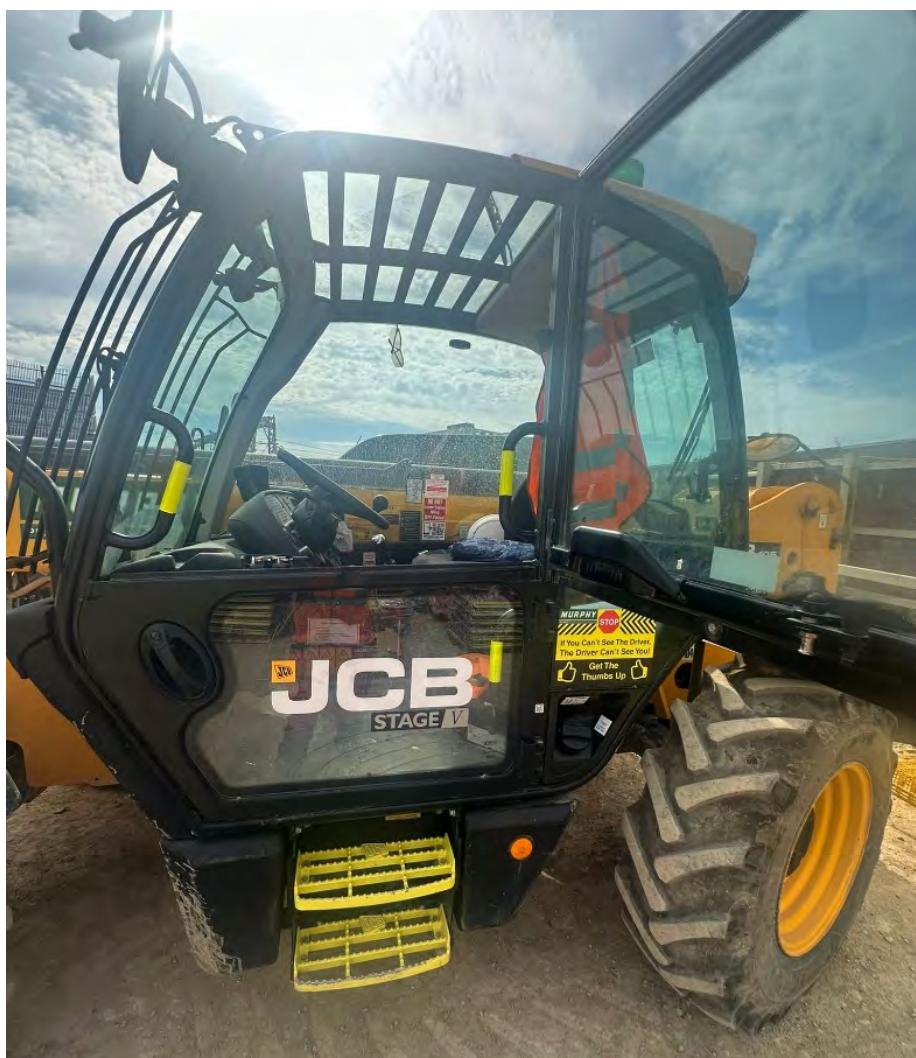
During offloading activities, the operator of a JCB 533-105 telehandler operator opened the top half of the cab's split door. Although the weather was sunny, a sudden gust of wind caused the door to swing shut, trapping the operator's left ring finger and causing a laceration injury.

- First aid was provided on site.
- The injured person (IP) was transferred to hospital for further treatment.

- The telehandler has been quarantined pending inspection.

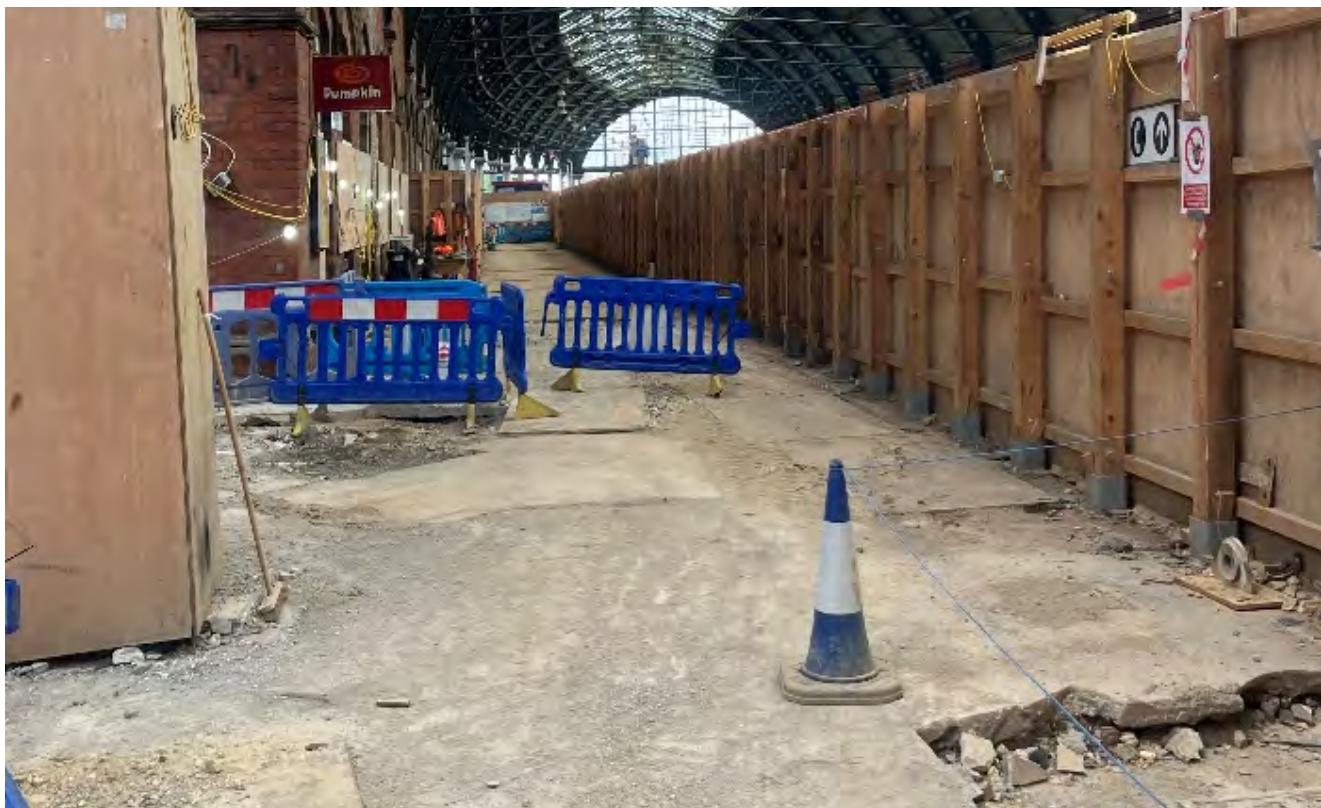
Works within the station building involved breaking out concrete using a breaker and a plate compactor which produced noise. The BAM supervisor had been checking with LNER during the week, and noise levels were deemed acceptable with no complaints. However, a different LNER Duty Team Leader disagreed on 02/07/2025. High winds also caused dust to blow around more than usual.

High winds caused dust to travel

No dust suppression was being used

Lack of communications between BAM & LNER with regards agreed working times for activity.

Work was stopped and re-arranged for Saturday night shift when Station would be closed to public.

Ensure all scheduled works of this nature are planned in for out of hours working.

- Share incident with site team
- BAM to ensure dust suppression is used at all times
- Reinstate the practice of signing out a radio from LNER to ensure direct communication going forward.

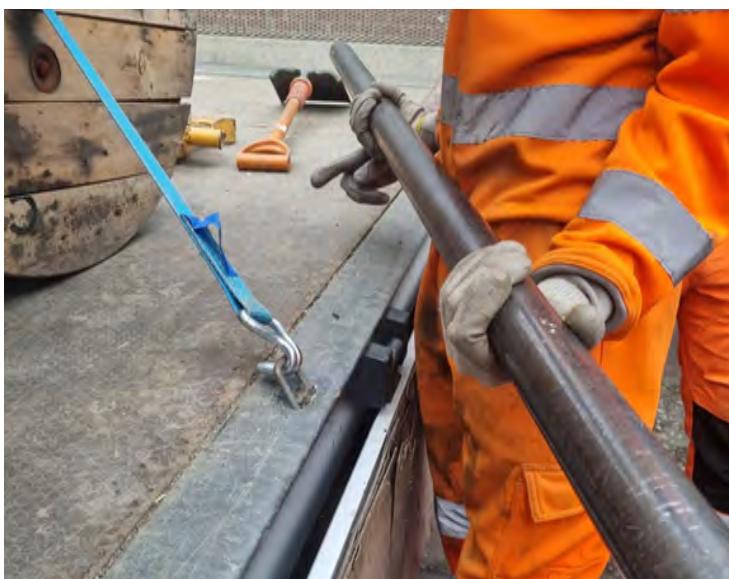
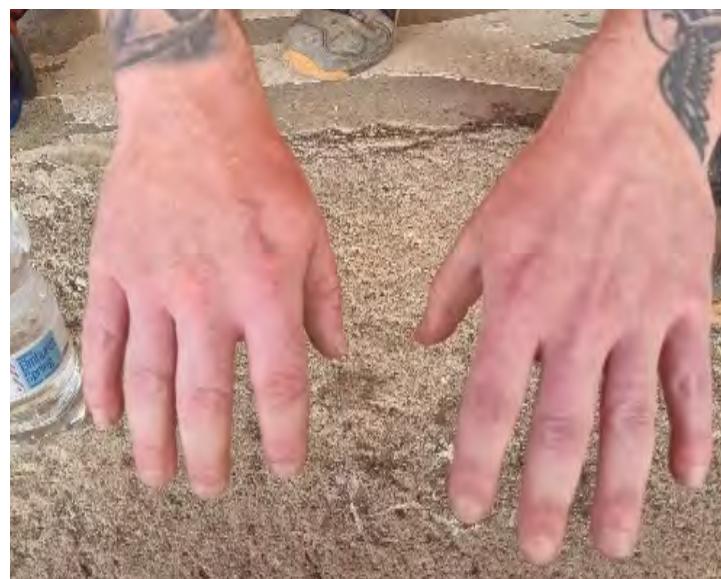
At approximately 16:00 on 3rd July 2025, during the process of loading a Siemens works van with cable drums in preparation for the following day's activities, a metal bar used to secure the drums was being positioned onto the back of the vehicle. While handling the bar, an operative accidentally dropped it, resulting in the bar striking the injured person's (IP's) right hand. This caused a minor impact/crushing injury. The IP promptly reported the incident to the Site Supervisor, who is also a qualified First Aider. Upon assessment, it was determined that a hospital visit was not necessary. The IP sustained minor swelling to the right hand but retained full mobility and reported feeling fit and well.

Task stopped and IP assessed by on-site First Aider.

- L1 Investigation to be completed

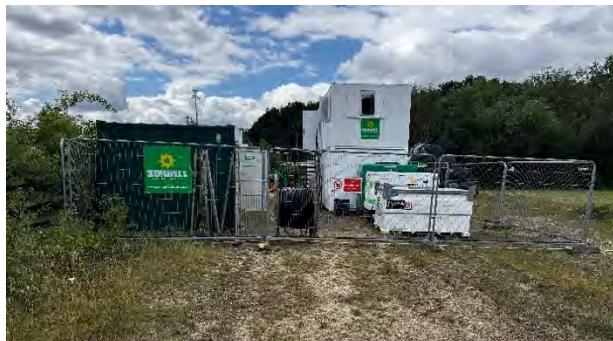
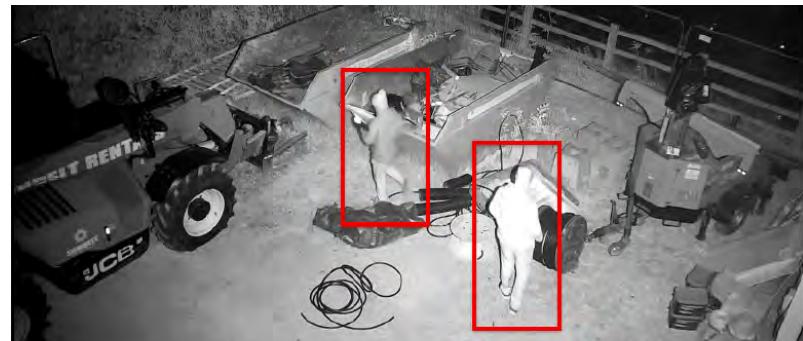
48-core and 2-core cables cut in multiple places, but none removed
Generator unplugged
Container doors had been tampered with but not accessed

Jumping over a wooden Network Rail boundary fence located on the main road
Clipping a Heras fencing panel in the back corner of the compound.

- WCCTV system operated as intended: intruders were disturbed, and a verbal warning prompted them to flee the compound.
- Waste cable had been left exposed next to the open skip.
- 48-core and 2-core cables were damaged during the attempted theft; however, no cable was removed.

- Site and WCCTV to review the current security system and assess potential upgrades.
- Local Security Company now engaged to act as first responders for any future attempts.
- Given the site's remote location and the area's high crime rate, review occupation patterns and apply SFARP to minimise times when the compound is left unoccupied—while also avoiding lone working scenarios.
- Replace open-top skips with lockable alternatives and ensure all cables, including waste, are securely stored.

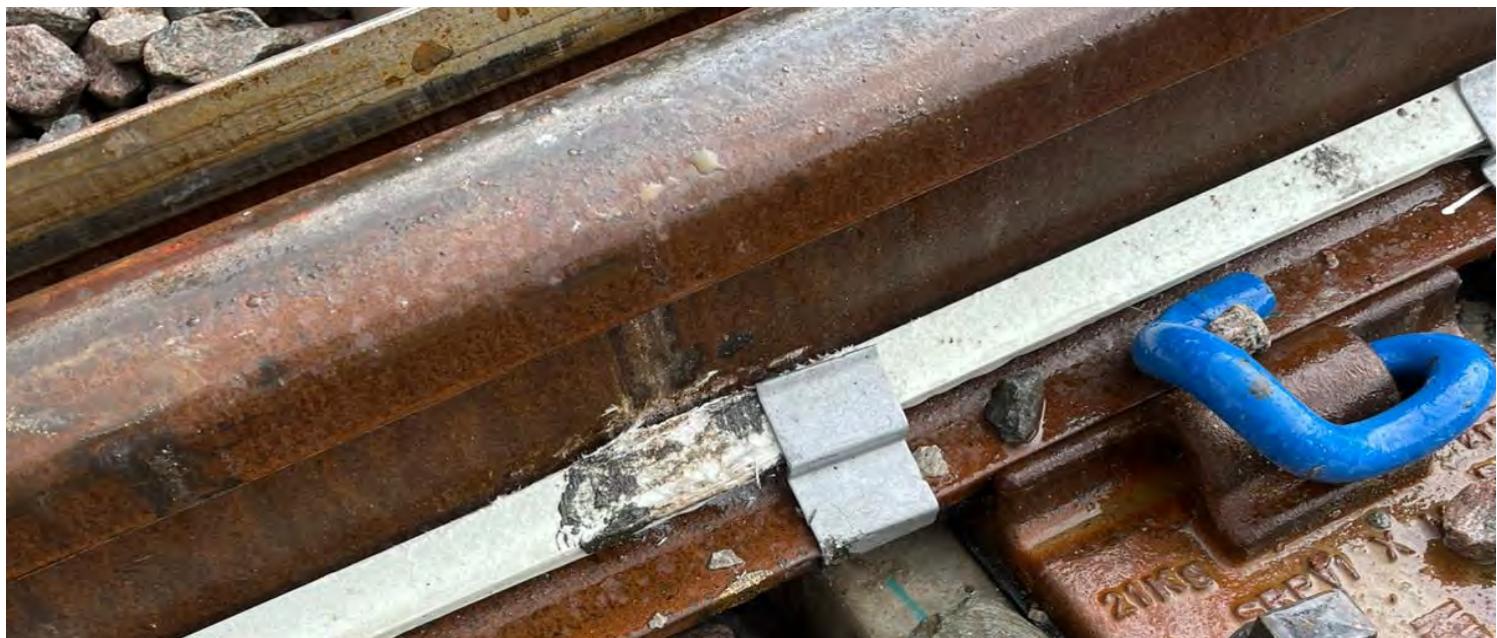
- Upon completion of tamping signalling staff identified damage to switch heating strip on 774 Pts.
- Damage is suspected to have happened during tamping caused by the lining wheel.
- This had not been reported during the tamping.
- The tamper that was working on the Down Main over 774 was 6Q62 operated by SB Rail.
- The tamper crew had been briefed on previous damage caused to points heart strips by the COSS.

Initial findings indicate the damage was caused by the lining wheel on the tamper.

- Damage assessed by E&P Supervisor and made safe.
- L3 on call informed.
- Close call and fast facts raised.

- Repairs to be completed next weekend.
- Level 1 investigation underway
- Discussions with SCO regarding briefing of tamper operators in progress
