CLIC

Issue 153 – 11th September 2025

Fast Facts

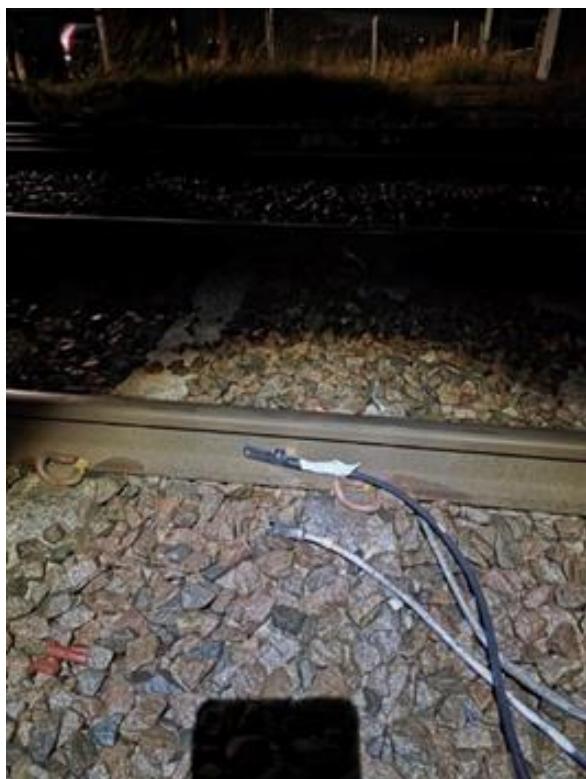
Once the trolley was fully loaded, the team began to move it clear of the level crossing and associated trespass guards. At this point, the Controller of Site Safety called out to the trolley operator to confirm that all materials had been securely loaded. In response, the operator applied the trolley's brakes to conduct a check. During this action, a 20-litre water container dislodged from the trolley and struck a Track Circuit cable (ST38) located in the rail web, resulting in damage to both the cable and its connection.

Although the incident was reported with sufficient time for the Fault team to rectify, the Controller Of Site Safety did not report the incident as it happened.

The materials were loaded on to the trolley without ensuring they were secure and couldn't fall.

The incident was reported to the Engineering Supervisor, who then escalated to the Signaller and Fault Control ref CCIL 993221. The Fault team attended site during the Possession and made the necessary repairs allowing right time hand back of the line.

- Next steps 1 Site teams stood down and briefed on reporting procedures.
- Next steps 2 Loads are to be assessed before travel
- Next steps 3 Investigation to be conducted

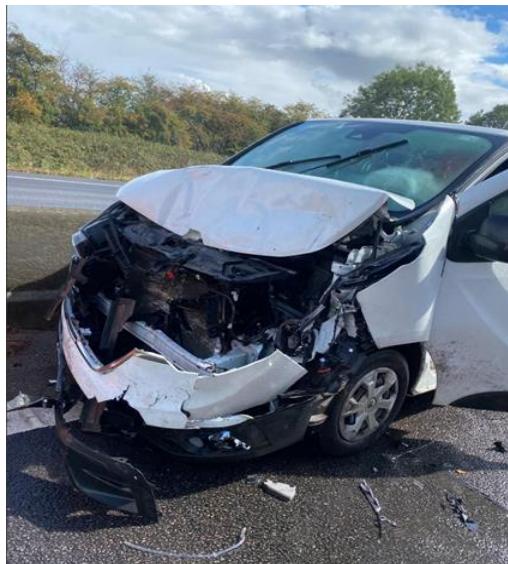
At approximately 14:30 on Thursday 4th September 2025, whilst traveling back home from site at Market Harborough a Subcontractor vehicle carrying 4 members of staff was involved in a collision on the M1 Northbound. Shortly after joining the motorway there was a multiple vehicle collision that resulted in the subcontractor van running into the back of the vehicle in front. Thankfully no major injuries were sustained with minor injuries being reported.

- Multiple vehicle collision in front and unable to react
- Changing weather conditions – Wet Road surface / spray.

- Staff stood down from work the next day Friday 5th September 2025
- Staff expected to return to work on Monday 8th September 2025 once alternate vehicle is acquired
- Further information / facts gathering to determine any contributing factors
- Lessons learnt and re brief to staff
- Liaise with Network Rail to close down IRIS

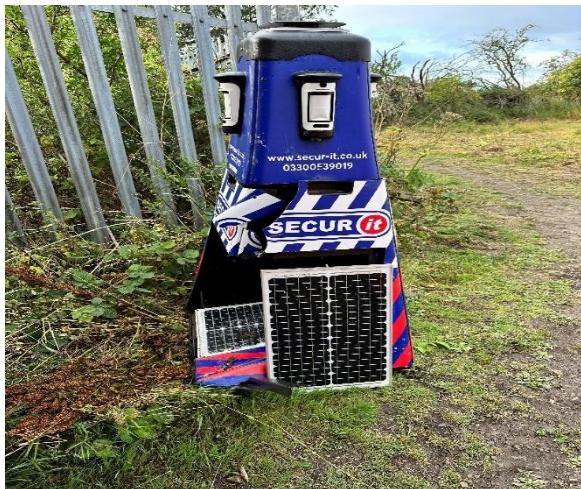
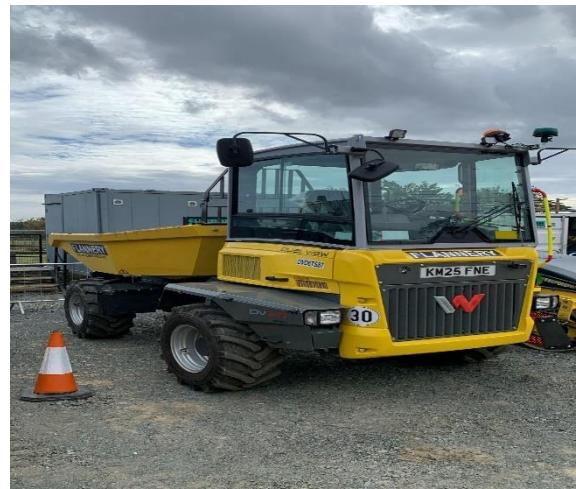
On 07.08.2025. At the beginning of the shift, approximately 08:05 hours, at the site compound, the dumper driver walked from the rear of the vehicle to enter the vehicle cab. Upon entering the vehicle cab, the operative proceeded to drive forward and as he did, the dumper came in contact with a Darlek CCTV positioned close to the vehicle in the compound.

- The dumper driver did not undertake the pre-use walk around checks before moving the dumper.
- Consequently, the dumper driver failed to notice the Darlek CCTV, which was positioned close to the vehicles parked in the site compound.
- No Banksman was present at the time of the incident.

- Banksman was deployed for all the vehicle movements in the site, and the site teams are using the Three-way det comms for all Vehicle movements.
- Level 1 Investigation in progress.

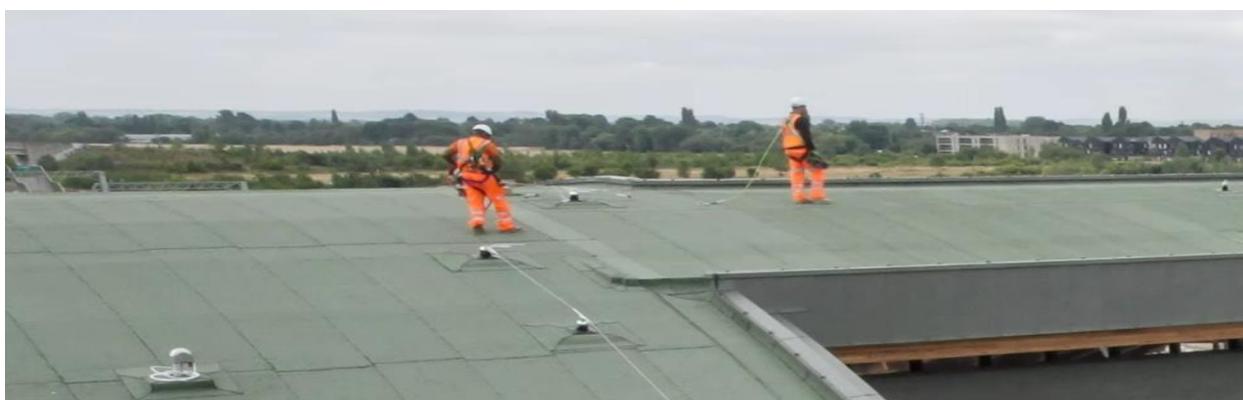
On the Cambridge South Enhancement project, two Electricians were identified working on the station roof without suitable edge protection or work restraint equipment in use. The planned activity consisted of cable re-routing for the irrigation system and the individuals had been briefed on the requirements to always wear work restraint equipment.

1. Inadequate review and approval process of methodology and risk assessment.
2. Inappropriate levels of supervision.
3. Failure to Speak Up and challenge unsafe acts.

- 1) The proposal for the works to be undertaken was accelerated and as such the Risk Assessment and Work Package Plan were presented late to the site manager for approval. This meant that all paperwork was not reviewed, and the author assumed that hearing nothing to the contrary, it was OK to proceed with the work.
- 2) The level of supervision provided for the undertaking of the task was deemed to be inappropriate and the lack of oversight for this activity enabled the workforce to commence works without adhering to the stipulated controls.
- 3) The team undertaking the works failed to act on their instincts of personal risk perception and challenge unsafe practices.

- Project team have undertaken a thorough review of nominated personnel as duty holders for Working at Height activities including:
 - Work at Height Coordinator.
 - Permit Issuer & Acceptor.
- Targeted safety standdown undertaken with the entire workforce with a key emphasis on the duty holders' responsibilities with individual letters of appointment issued for accountability and ownership.
- Implementation of area Supervisor allocation for the project clearly defined.
- Fair Culture model proceedings for individuals directly involved in the event.
