# CLIC

Issue 156 – 1<sup>st</sup> October 2025

Continuous Learning & Improvement Cascade  
Capital Programmes Eastern

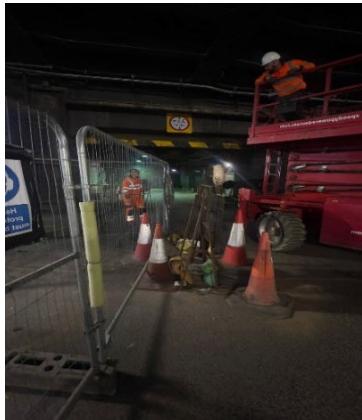
On the morning of Thursday 11th September 2025, a third-party hire company were in the process of delivering a scissor lift, having been ordered by Kent Group to Leeds Station to facilitate cable containment installation works. Upon delivery of the scissor lift, the driver of the hire equipment was asked to leave the plant external to the site of works for the competent Kent operatives to then transport into the site of works, of which they are inducted to carry out works within. However, the delivery driver had drove the lift into the site of work where it was immediately apparent that it was fuel powered. As a result of this and the size of the plant, the exhaust(s) of the lift have created a sizeable dust cloud (pictured below). Causing the internal smoke alarms at the site of works within Leeds Station to be raised, and subsequently station management to attend the site immediately to investigate. Luckily, a station wide alarm had not sounded so no evacuation of the station was implemented. A battery powered scissor lift was requested to mitigate any risks associated with fuel powered lifts. However, the hire company had provided equipment that was not suitable for use in the location specified.

Scissor lift outside  
the entrance to  
the  
site of works

- Cause 1: Despite following the correct process to request an electric scissor lift from Speedy Hire to mitigate the risk of triggering the fire alarm, the supplier failed to identify the specific requirement and recommended and provided a diesel lift. This oversight was not detected prior to placing the purchase order.
- Cause 2: Site teams did not verify that the delivered equipment matched the specified requirement and accepted a diesel scissor lift instead of the requested electric model.
- Cause 3: Existing excessive dust accumulation at the station entrance posed a potential safety hazard, vulnerable to setting off the fire alarm.

- Action 1: Coordinate with the station team to isolate the fire alarm following additional surveys for future work in this area.
- Action 2: Conduct a thorough sweep of the road prior to any further works in the affected area.
- Action 3: Ensure site staff verify all future deliveries against the specifications established during planning and survey stages.
- Action 4: Better assurance at planning stages, to eliminate the requirement of diesel-powered equipment, and where possible, substitute for electric.
- Action 5: Enhanced communication to be implemented during the event reporting stages to all clients and stakeholders.

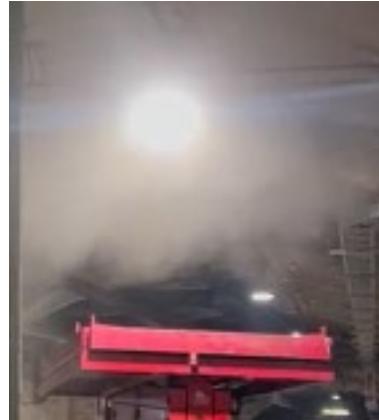
\*Dust cloud created as  
a result of the exhausts  
of the scissor lift.(from  
video taken on removal  
of the equipment after  
the event).
