SAFETY ALERT

Minor Accident – Foxton 28th of December

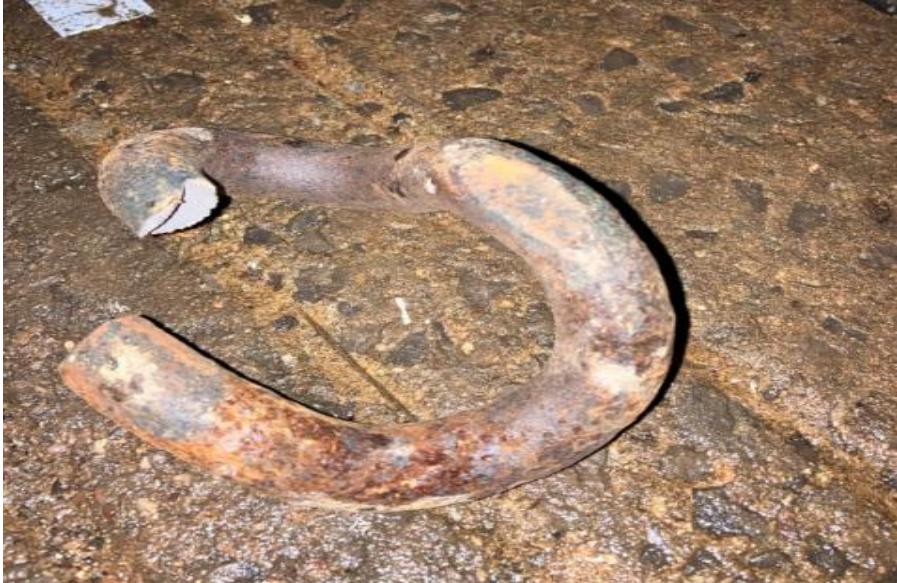
- Trackman was removing a pandrol key with a keying hammer which was seized in the housing, the clip snapped upon impact resulting in the clip ricocheting approximately 15m along track and striking the left knee of a Crane Controller.
- The trackman was de-clipping a pandrol key on an old track section ahead of the re-railing sequence and failed to place his boot on the pandrol key to prevent the pandrol key from flying off and making contact with a member of the staff.
- The trackman was hitting the pandrol key both ways to aid in releasing the clip, when the clip snapped, he was hitting the clip into the housing which is why he did not have his foot over the clip. The trackman wasn't expecting for the key to snap whilst hitting it into the housing.

Project team recommended - when removing seized pandrol keys, ensure competent staff are undertaking the task and a sufficient exclusion zone is in place

- Take 5 prior to work and assess the site for any uncontrolled hazards.
- Ensure there is an exclusion zone in place.
- Ensure all work parties are aware of the activity.
- Do not undertake works until it's safe to do so.

- Ensure the person undertaking the task is competent.
- Ensure the pandrol clips have been sprayed up with lubricant.
- Ensure only the required staff is present within the exclusion zone.
