# CLIC

## *Safety Events Digest*

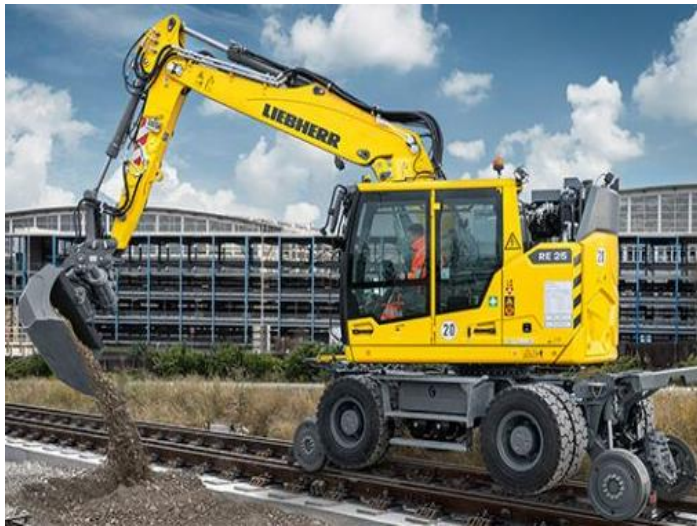
- Liebherr 920 RRV Fleet No 7198-machine burst its main drive pipe.
- This resulted in a spray of approximately 5 litres of Hydraulic oil.
- A spill kit was deployed, and there was no contamination identified.

(Not actual RRV that had oil leak)

- Hose Failure

- Confirm all hoses have been inspected for wear & tear before next deployment.
